The 8<sup>th</sup> International Forum on the Decommissioning of  
the Fukushima Daiichi Nuclear Power Station

# Initiatives for Fuel Debris Retrieval at Fukushima Daiichi Nuclear Power Station

August 26, 2024

Fukushima Daiichi Decontamination and Decommissioning Engineering Company,  
Tokyo Electric Power Company Holdings, Inc.

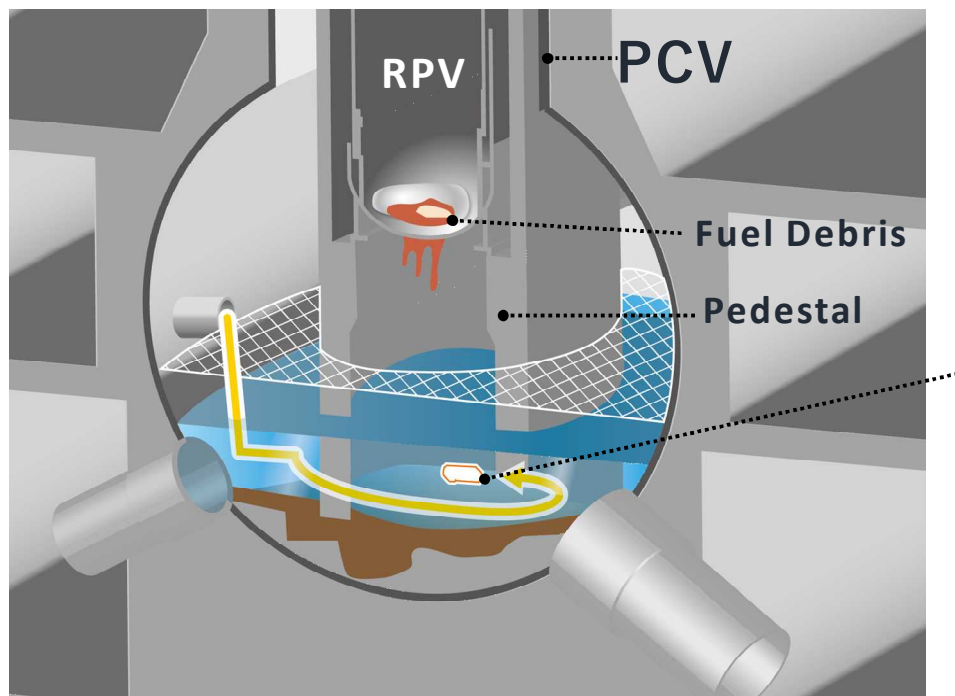
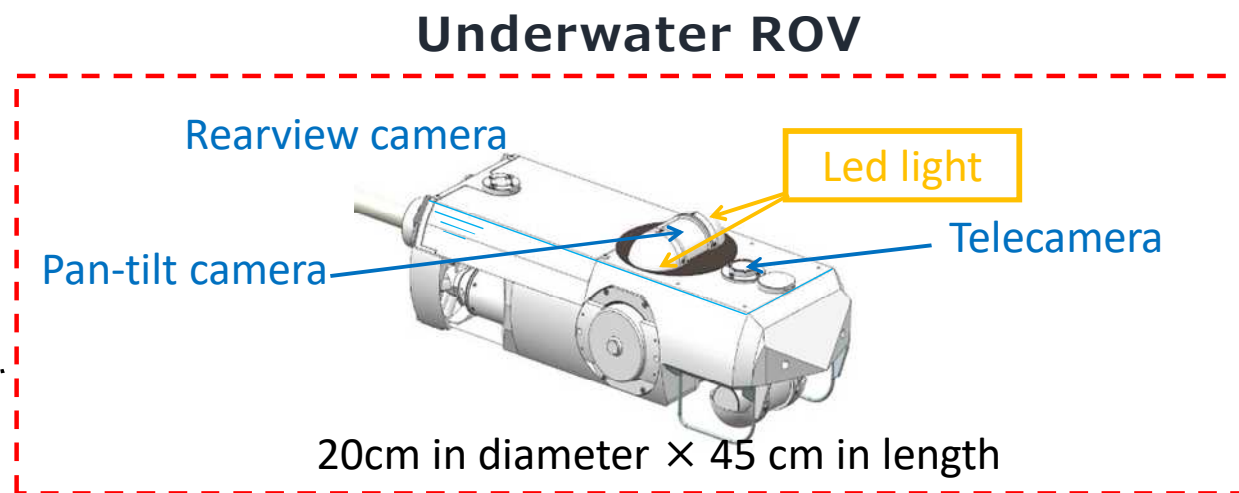
- Shelf-like deposits were found 1 meter from the floor, with concrete missing and rebars exposed around the entire pedestal's circumference beneath this level.
- Deposits rising up to 1 meter were observed across the floor.
- Structures that fell from the upper side were identified.

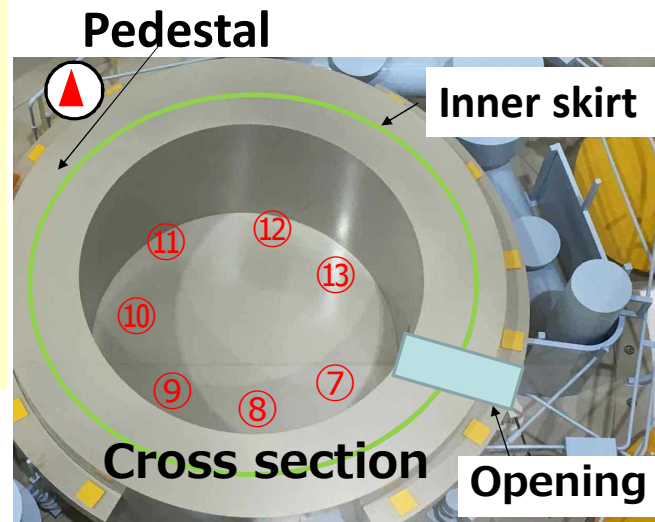
Opening on the left side

Opening on the right side

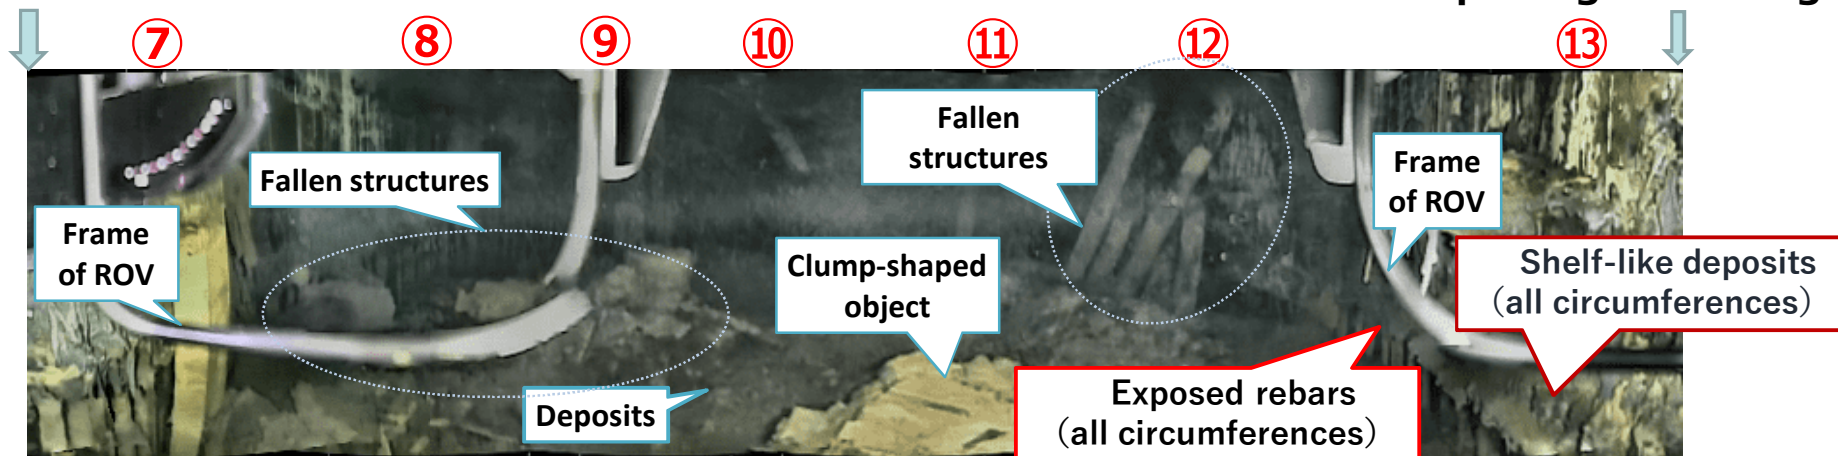
- In contrast to the lower part, the upper part of the pedestal has been found to remain intact.

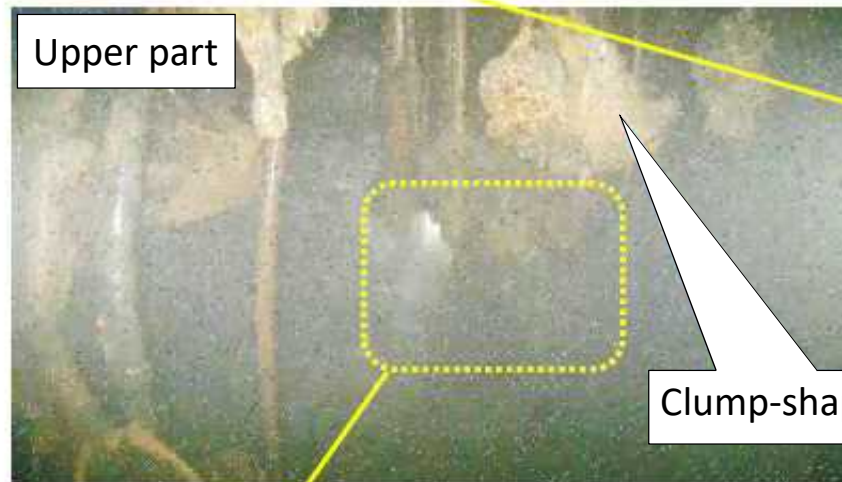
Upper part

Clump-shaped object

Icicle-shaped clump

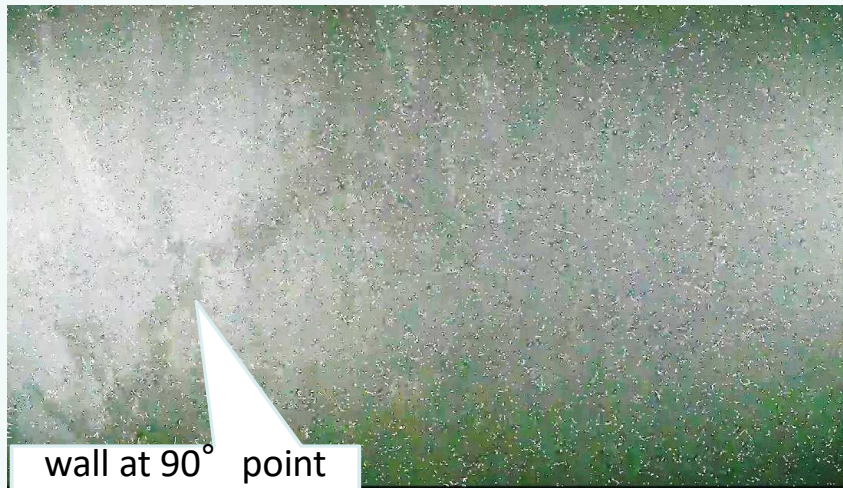
**Photo1** : Wall at 90° Point inside the pedestal

- No significant damage was confirmed despite a color change, and the concrete remains intact.
- No equipment was observed, as there has been none since before the accident.

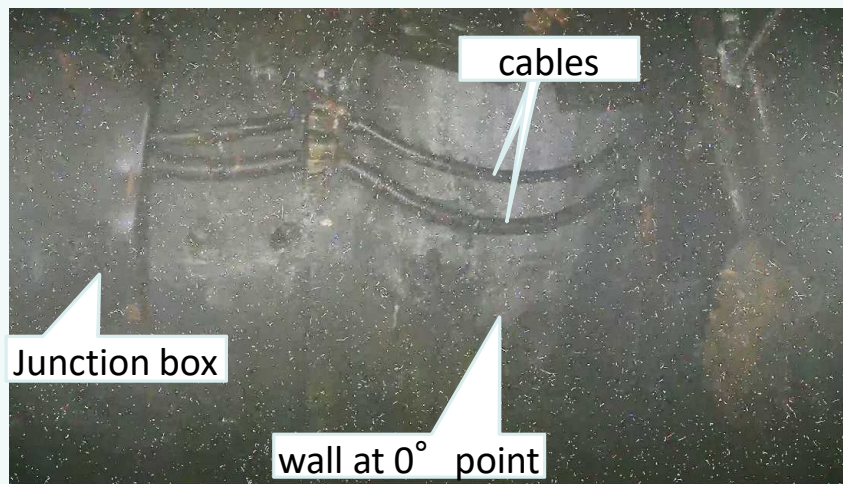
**Photo2** : Wall at 0° Point inside the pedestal

- Like photo 1, No significant damage was confirmed despite a color change, and the concrete remains intact.
- Objects including a junction box for cables were observed. It is presumed to have changed in color and shape.

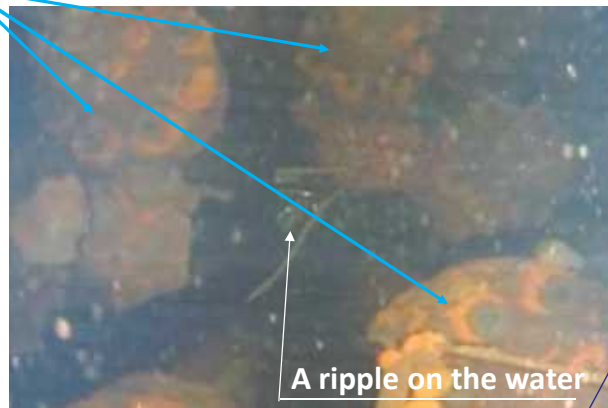
**A cylindrical structure (presumed to be a CR guide tube)**

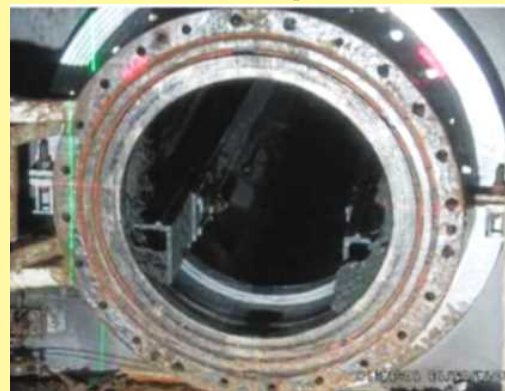
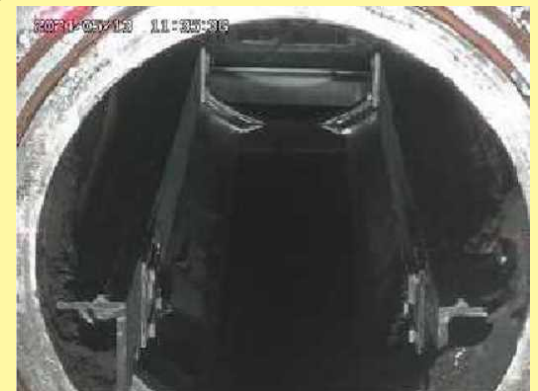
Removal of deposits completed

- Deposit removal equipment was installed to secure the access route for trial retrieval equipment.
- By squeezing deposits using low and high-pressure water and cutting cables using AWJ\*, the whole process was completed in May 2024.
