Estimation of current status inside RPV and PCV at Fukushima daiichi NPS

July 3, 2017

Tokyo Electric Power Company
Holdings, Incorporated
Shinya Mizokami

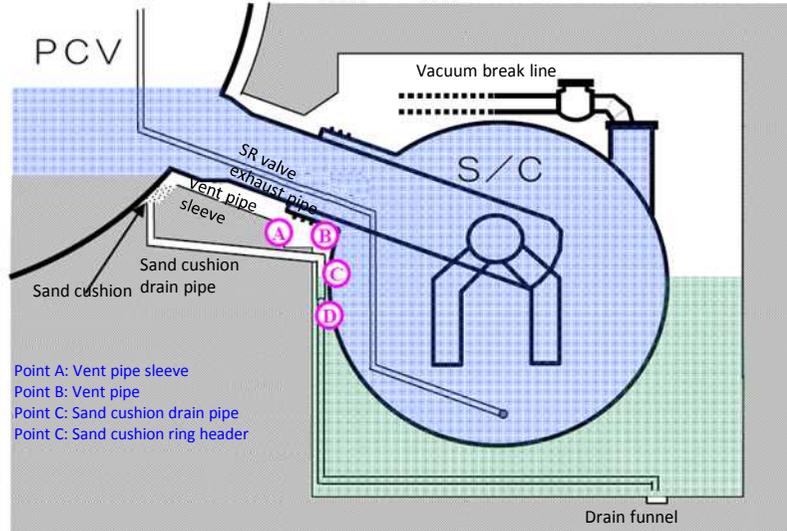
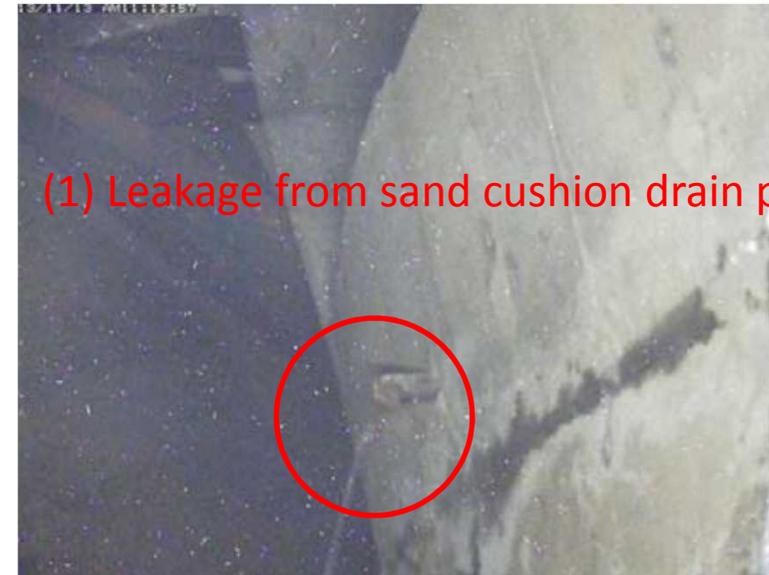
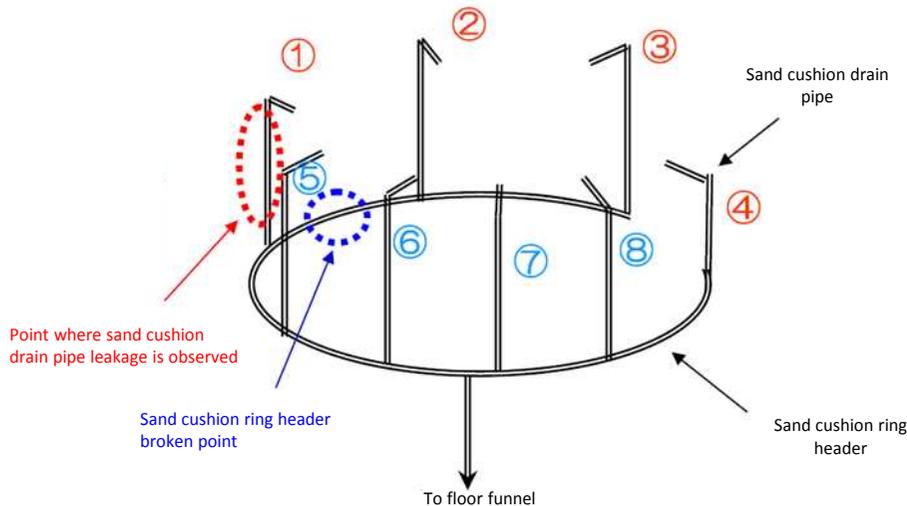
1-10 Leakage from Sand Cushion Drain Pipe

Using the video camera mounted on the remote boat, confirmed water leakage from the vent pipe and sand cushion drain pipe (November 13 and 14, 2013)

Leakage is observed from sand cushion drain pipe. Although the location cannot be identified, the iron shell below the water surface could possibly have a leakage point.

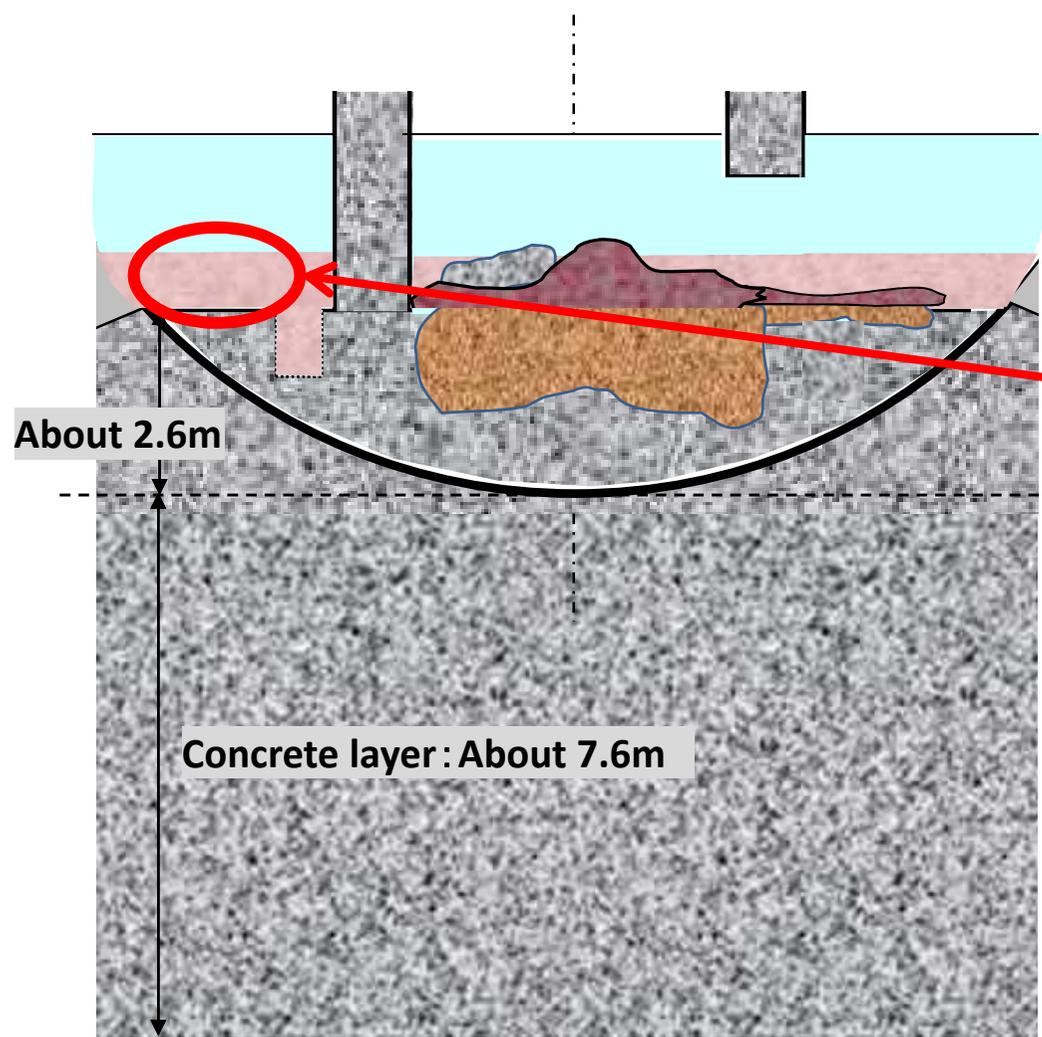
1-11 D/W Floor Condition

▪ The video image taken by the underwater CCD camera on D/W floor shows something like deposited sediments

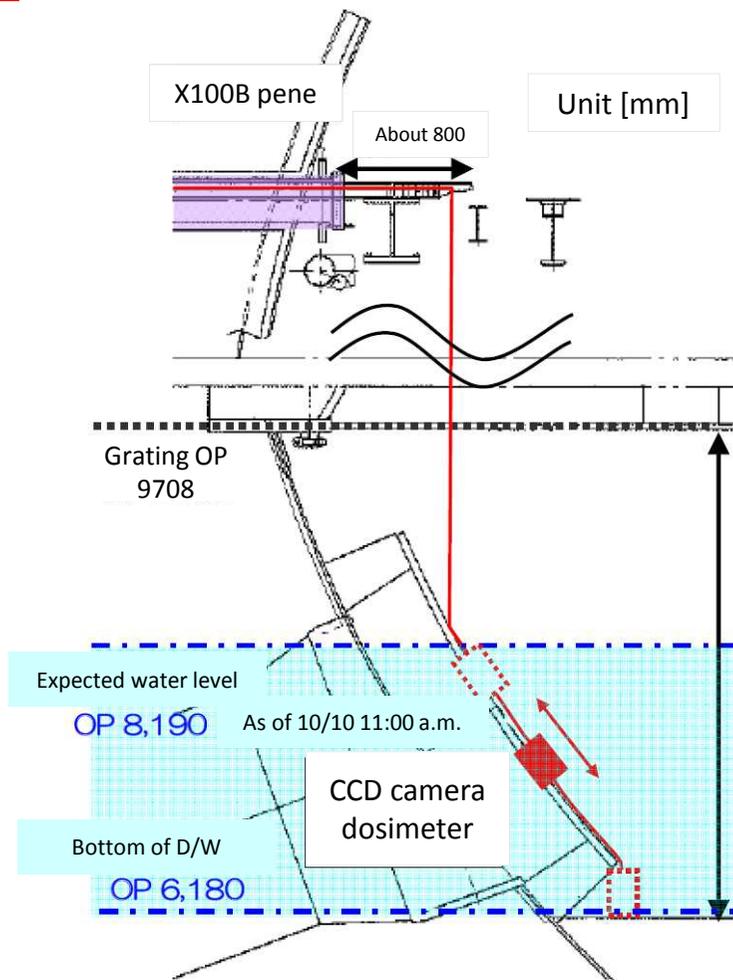
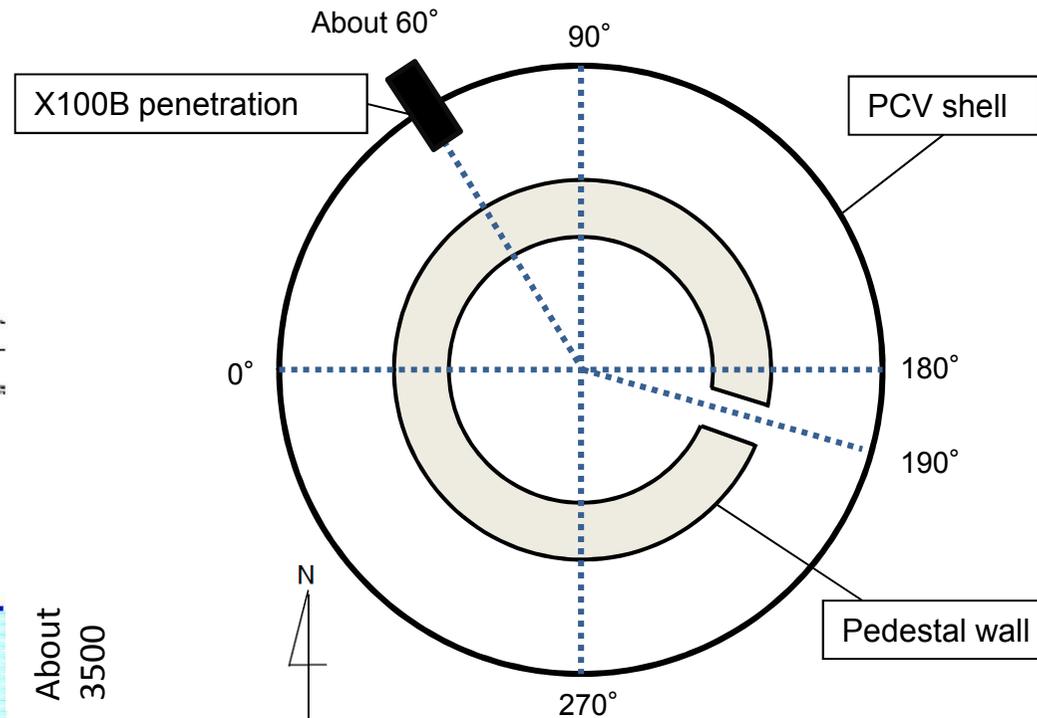
1-12 Result of PCV Internal Investigation

The dose in the air on the first floor in PCV is 4.7 to 9.8 Sv/h
 About 11.1 Sv/h at the end of pene when inserting the instrument
 Dose distribution tends to decrease as height decreases
 0.5 Sv/h underwater in accumulated water

As a PCV internal investigation, CCD camera was inserted from X100B pene (October 11, 2012)

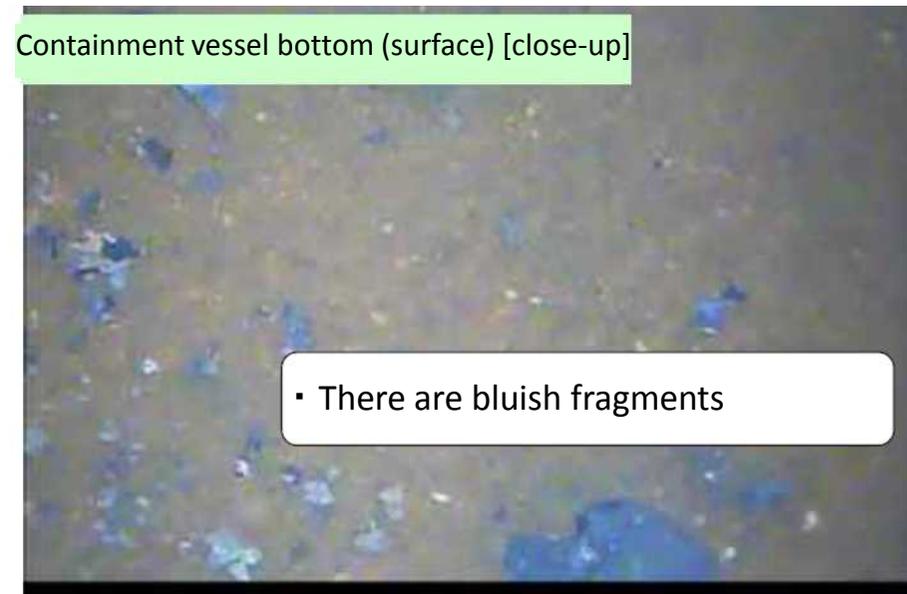
1-13 Result of PCV Internal Investigation

There are some deposits having a certain thickness at the bottom of containment vessel. Deposit seems not to be hard solids as it had a dent when the camera bumped it. Some deposits are bluish fragments. (Possibility of lead)

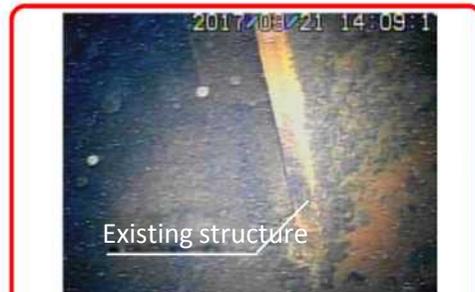
3/21 D3 Image near the lowest point

Deposits having a certain thickness are observed in each observation point in the same way as the investigation in 2012.

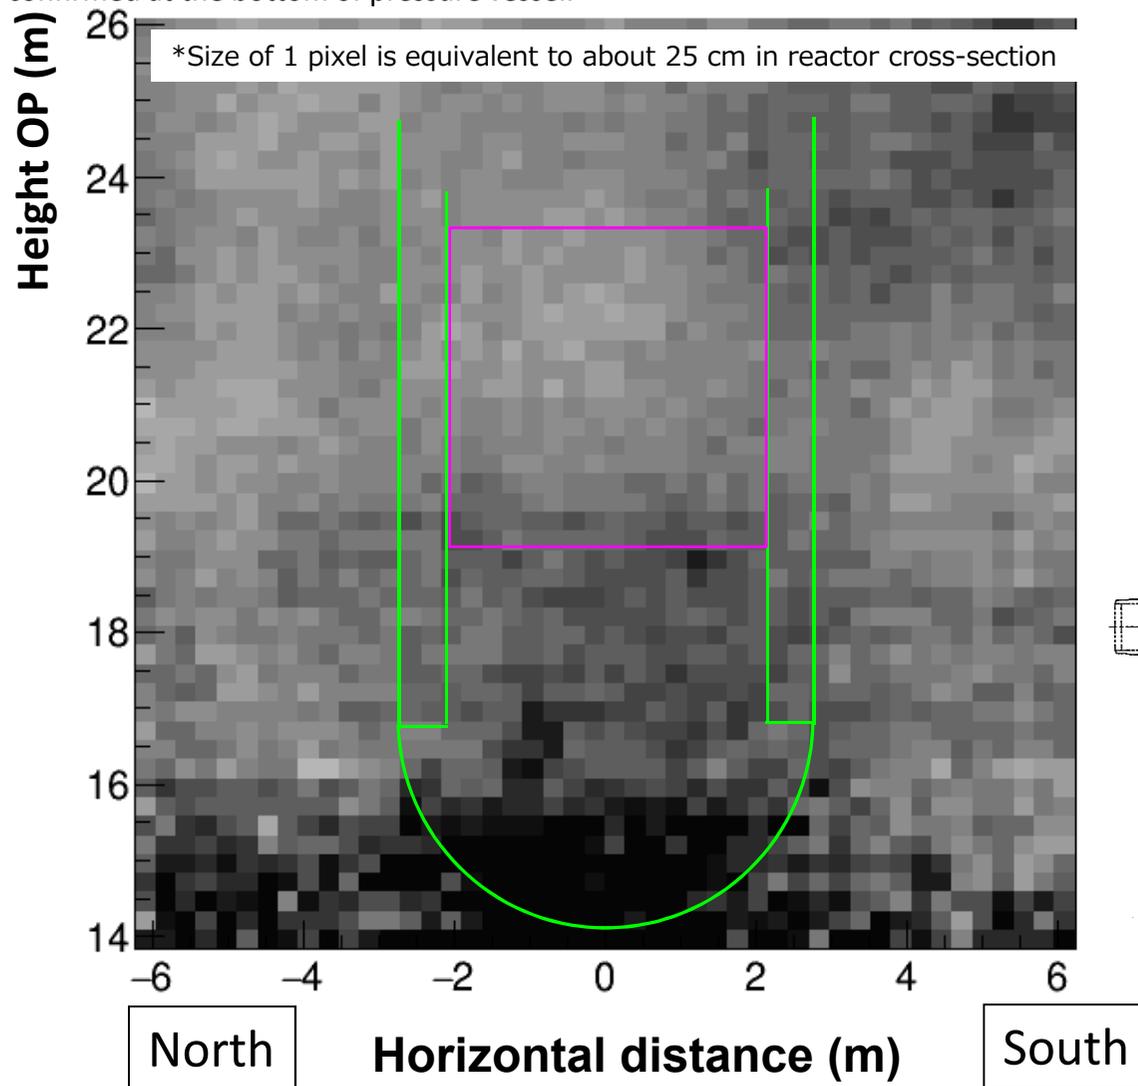
2-12 Result of Muon Measurement

- A shadow of the high density material that is considered to be fuel debris has been confirmed at the bottom of pressure vessel.

Considered that fuel fallen in the lower plenum remains at the bottom of RPV.

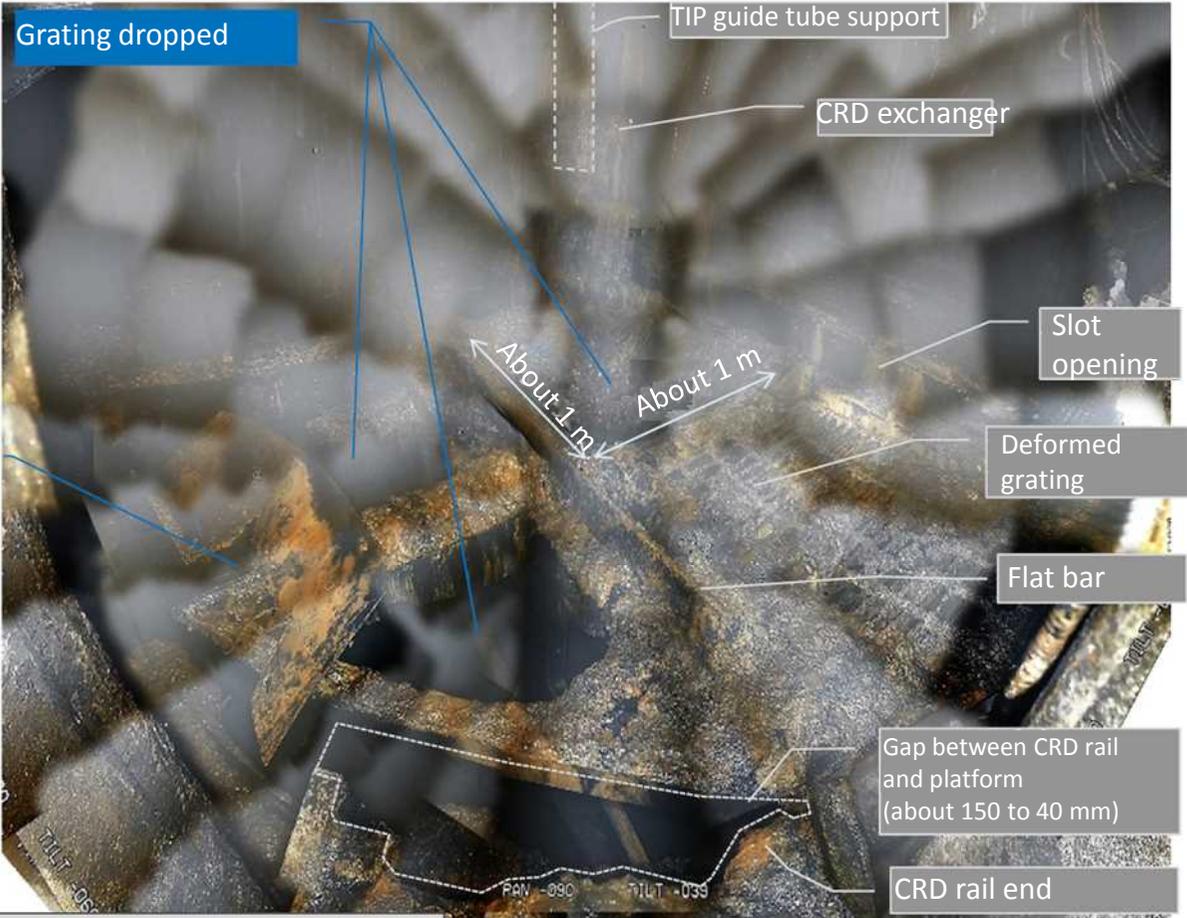
2-15 Result of Unit 2 Containment Internal Investigation

Image of inside the pedestal looked through from CRD rail
 Sharpening process allows us to view the position far away from camera

- Grating dropped on the left side of slot opening
- Steam rises from lower grating
- Grating not dropped out is observed to have adhered deposits and deformation

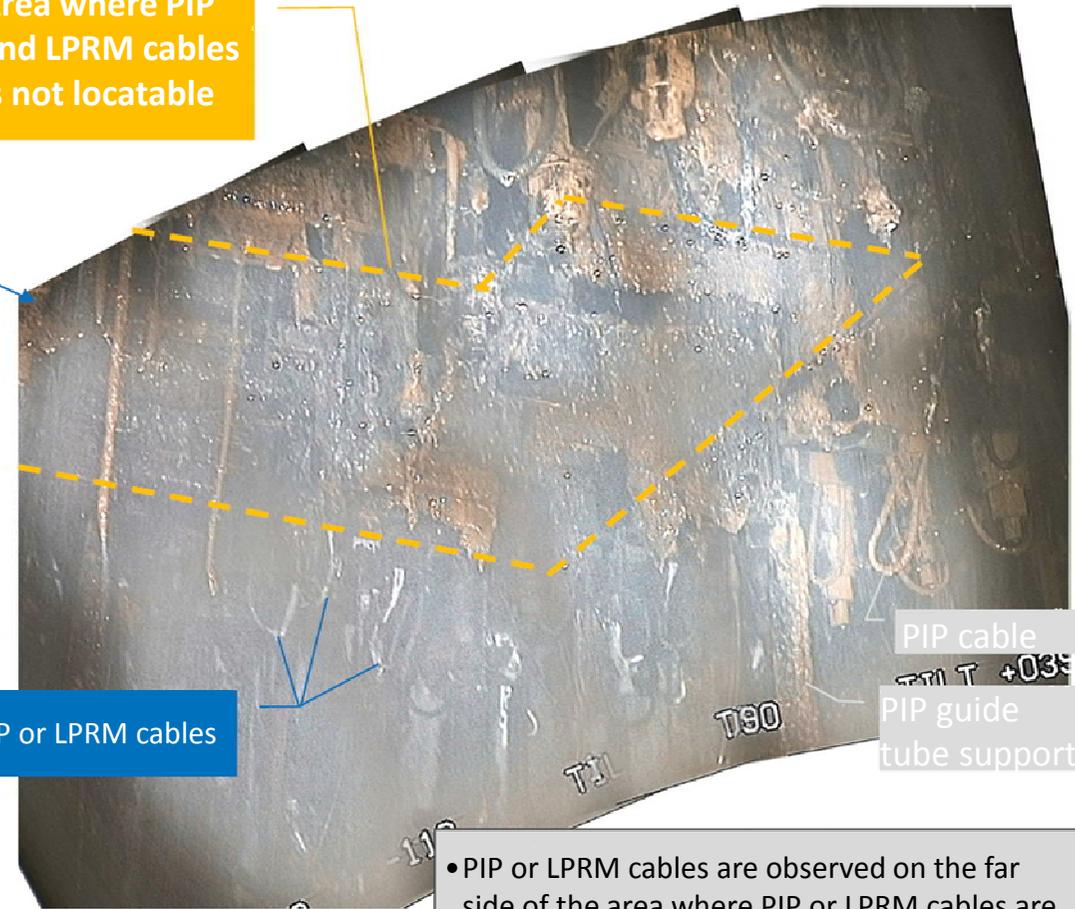
2-16 Result of Unit 2 Containment Internal Investigation

• PIP or LPRM cables are observed on the far side of the area where PIP or LPRM cables are not locatable

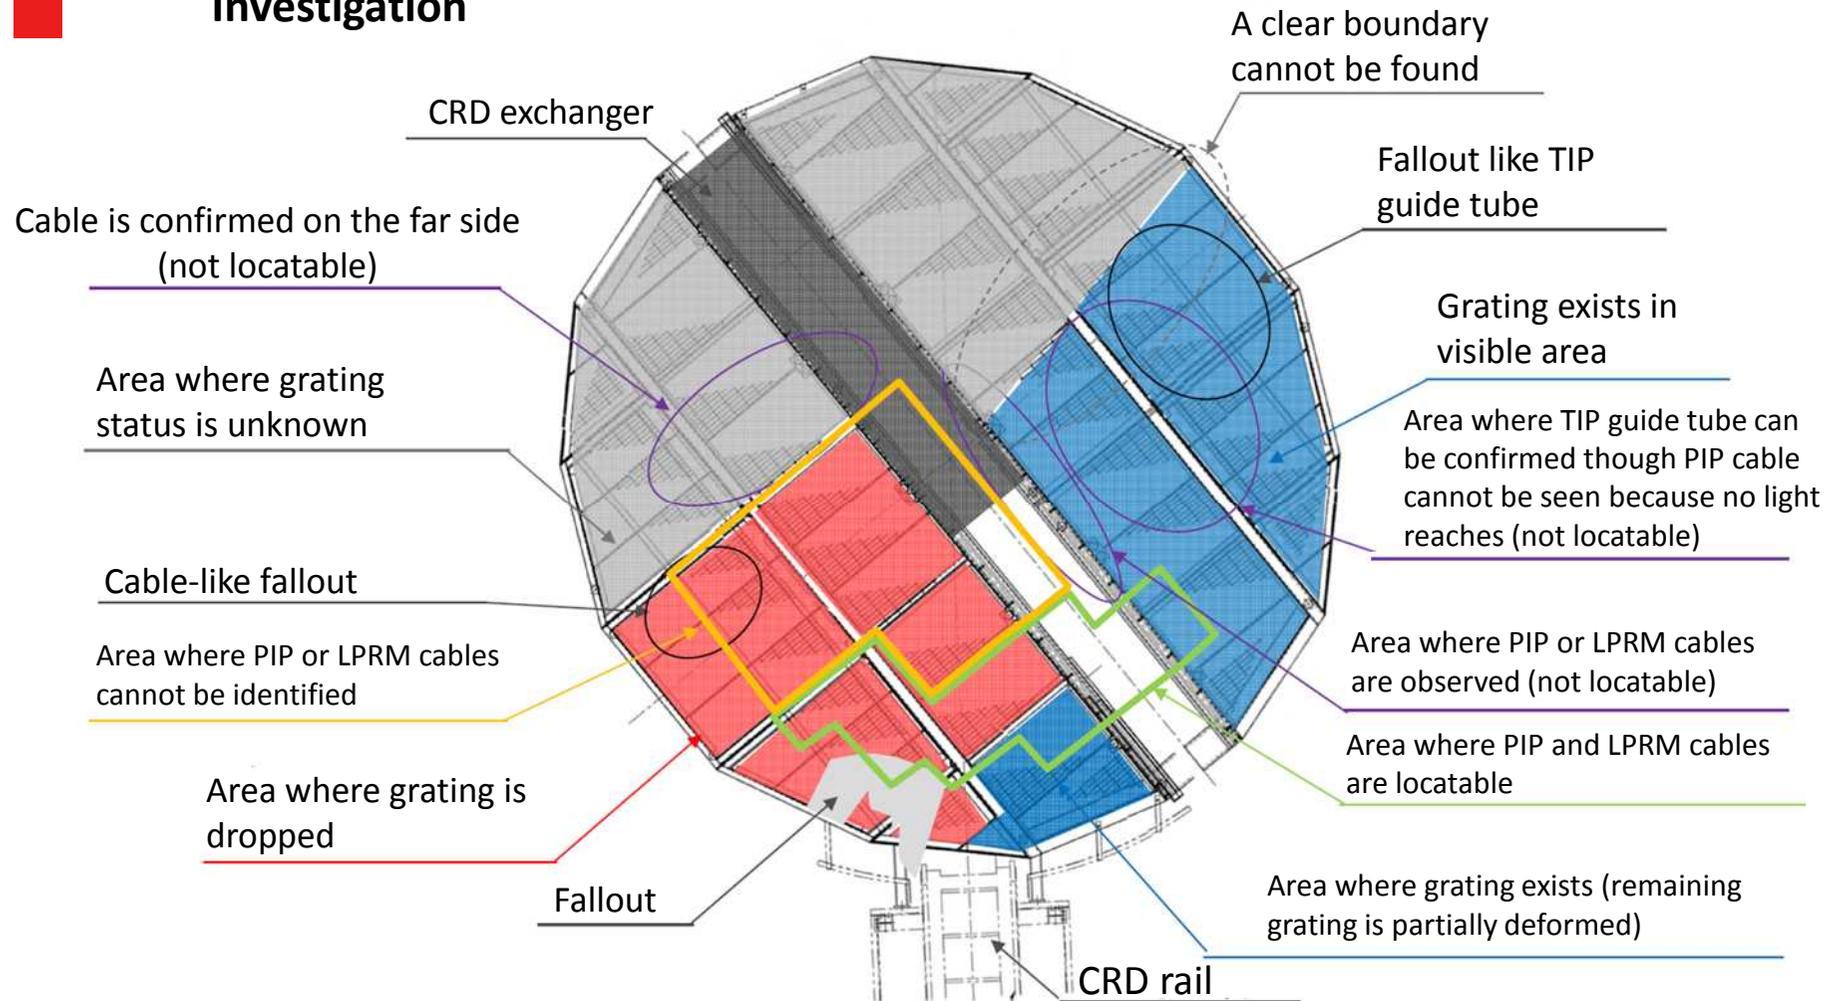
2-17 Result of Unit 2 Containment Internal Investigation

- The area where grating dropped and the area where cables under the pressure vessel are damaged generally match.
- Deformed grating could possibly be associated with fuel debris fallen and damaged points other than those in the center of pressure vessel.

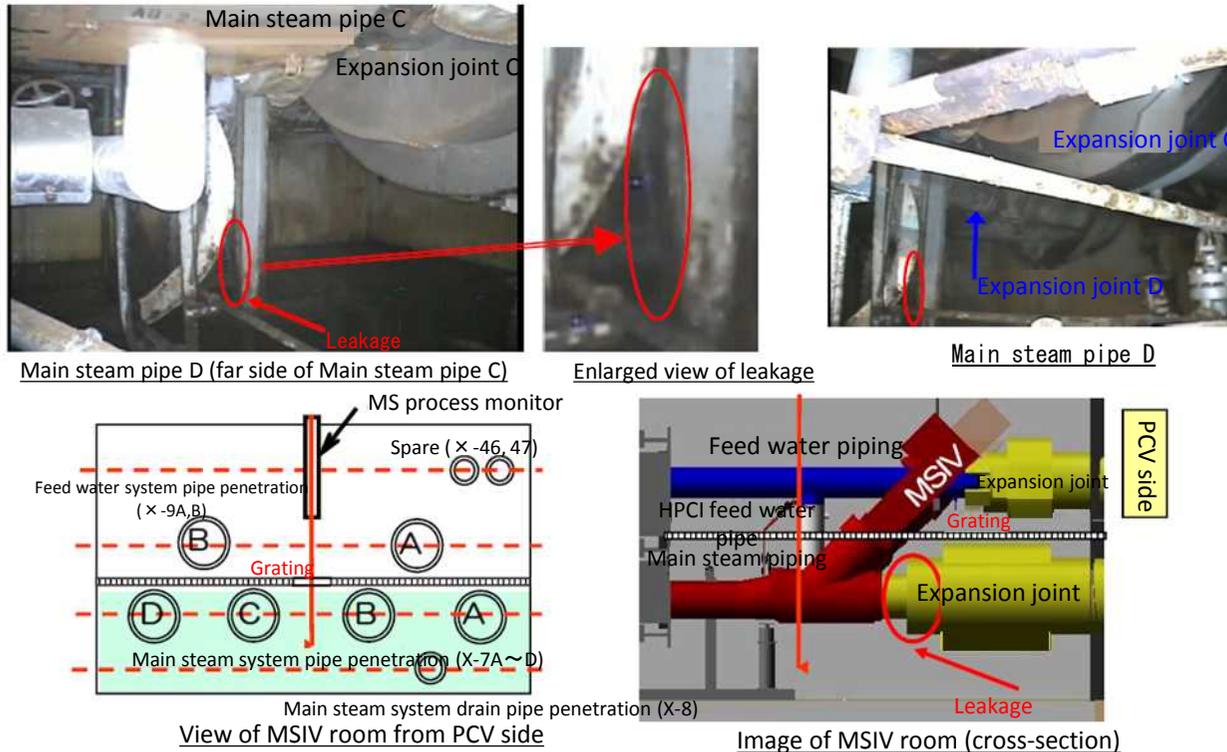
3-8 Investigation Result of MSIV Room

- Leakage is observed from the periphery of the expansion joint of main steam pipe D.
- Leaked water is estimated to be the volume of 2 to 4 pencils.

- At Unit 3, water level in the containment vessel is relatively high (about 6 m) compared to Units 1 and 2. May 15, 2014, after the investigation of MSIV room, leakage of water is observed from the periphery of the expansion joint of main steam pipe D.
 → Because the containment vessel maintains a high water level, it is not considered to have reached shell attack.
