Managing uncertainty in a complex and hazardous environment: experience with the Pile Fuel Cladding Silo

Edwin Matthews

Head of Strategy and Technical, Retrievals, Sellafield

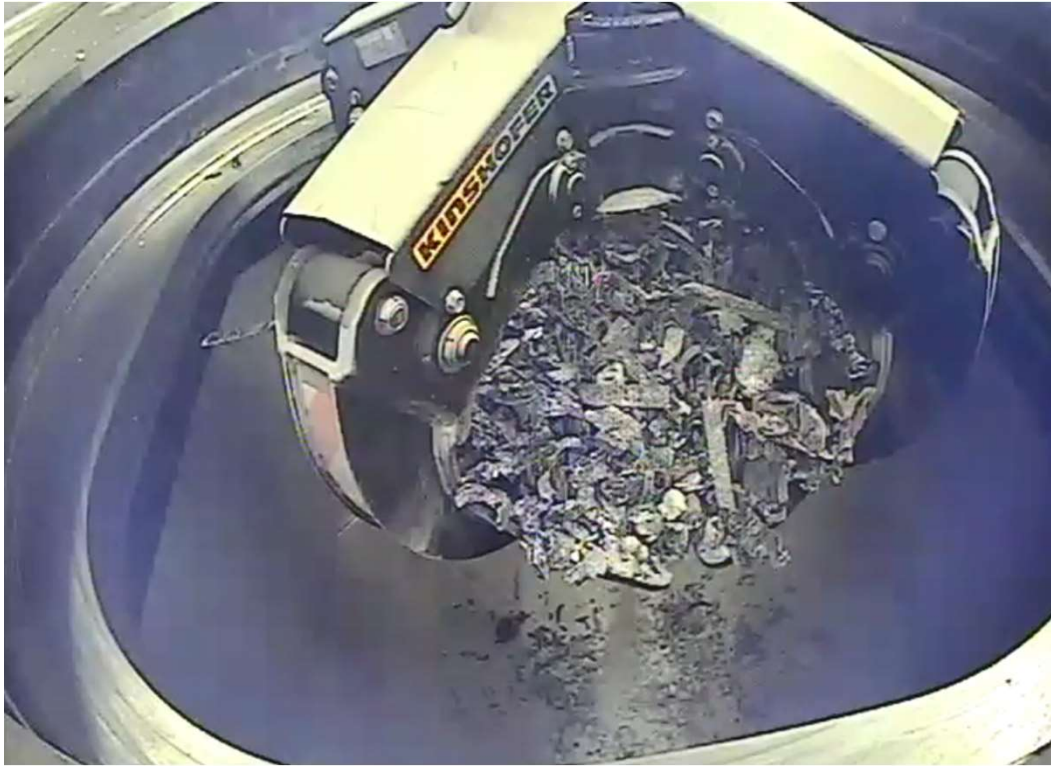
- Waste being retrieved

- These images show the problem being faced with dust

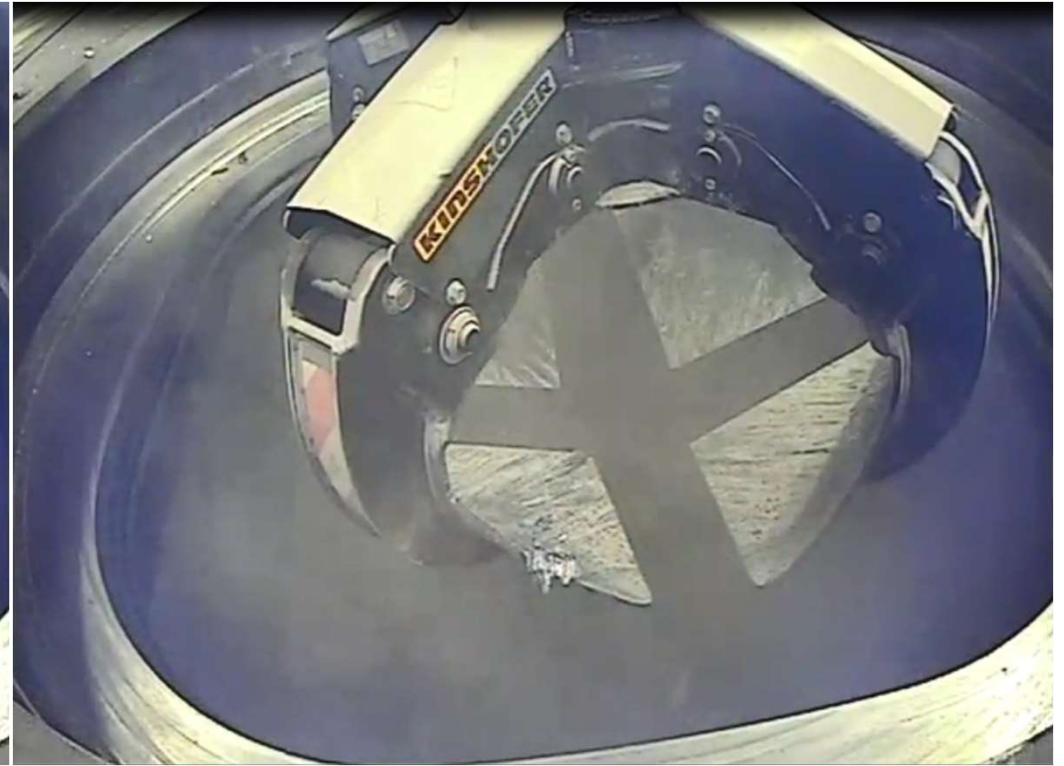
- Dust plume generated when waste is put into the container

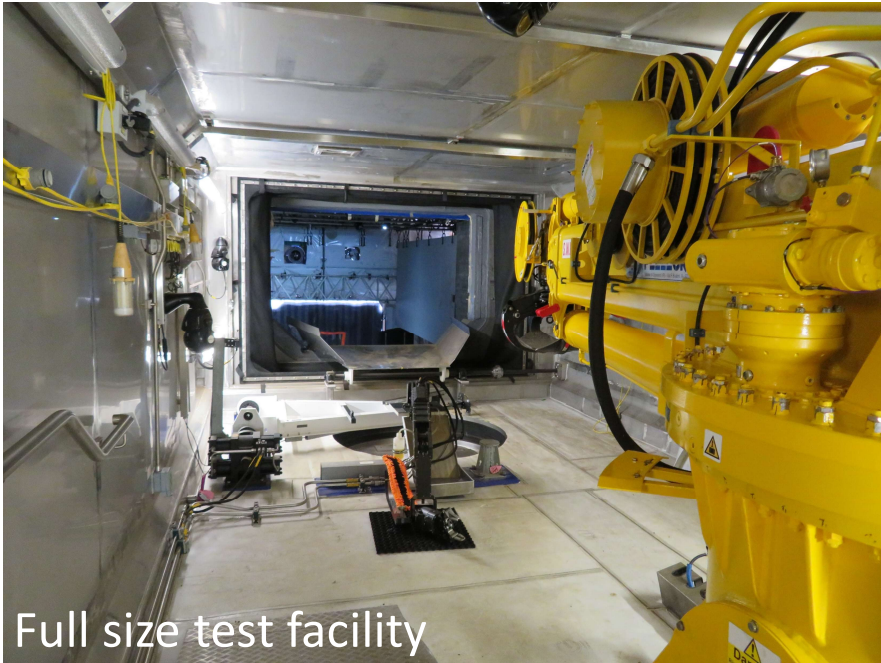
Full size test facility

- First, a problem statement is defined by personnel familiar with the facility.
 - This is sufficiently detailed that a project team (from Sellafield and the supply chain) can devise solutions
- Constraints are identified through collaboration between the project team (responsible for developing this solution) and facility representatives (operational teams)
- Solutions are developed from a test rig up through prototyping then up to full scale
- Recommended solution identified
