Managing of the damaged fuel at Paks NPP

Larisza Szőke head of nuclear fuel section, deputy project leader (encapsulated fuel management project)

1st International Forum on the Decommissioning of the Fukushima Daiichi Nuclear Power Station 11 April 2016

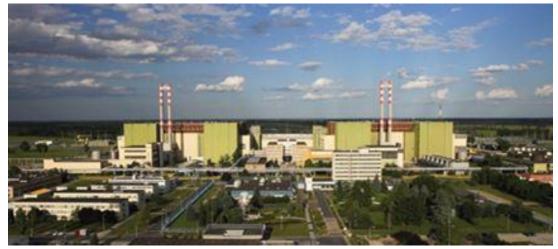
4 VVER-440 type Units; Commissioning time: 1982-1987 Original design: 1375 MW, 440 MWe, After power uprate project 1435 MW, 500 MWe

2000 MW, > 50% of domestic production

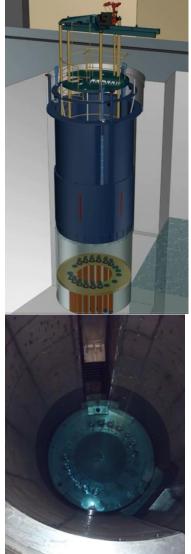
TECHOLOGY used for drying and hermetical sealing the canisters

In second half of 2013 all 68 capsules containing the spent fuel were successfully dried out.

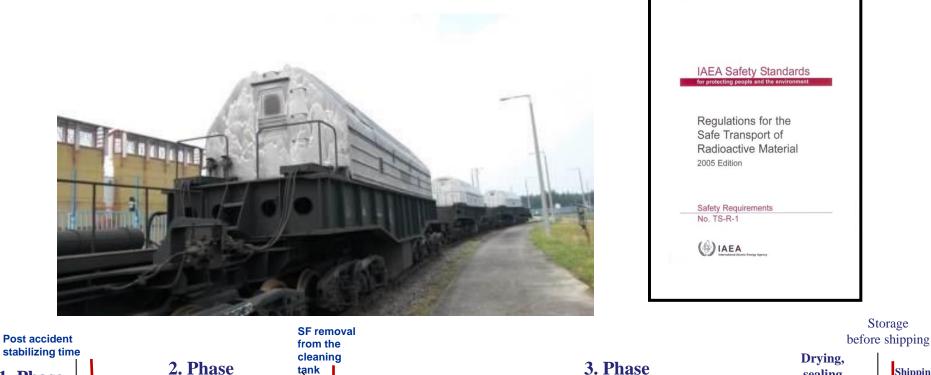
Shipment of the SF to the reprocessing facility

In summer 2014 the capsules were successfully shipped to Russia to "Mayak". By this <u>the project for full recovery of the consequences of the accident of 2003</u> <u>was successfully completed</u>.
