# EXAMINATION AND EVALUATION OF DEBRIS FROM THREE-MILE ISLAND UNIT-2 (TMI-2)

presented by P. D. W. Bottomley (JAEA Invited Researcher)

# Three Mile Island (TMI-2)

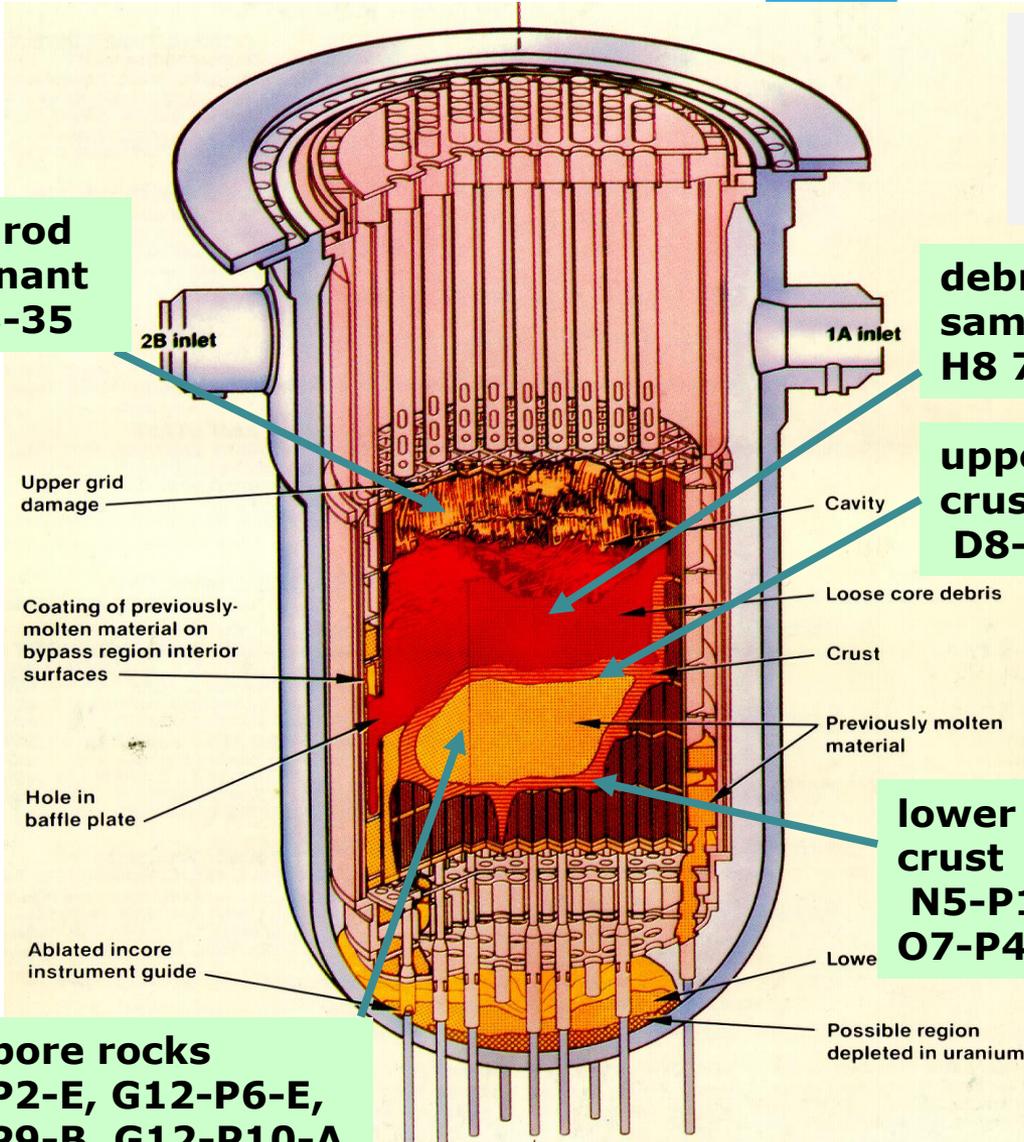
## Damaged core of the TMI-unit 2 reactor in its end-state

**fuel rod remnant  
C7 3-35**

**debris samples  
H8 7.2-7.9**

**upper crust  
D8-P2,3**

1) molten core (yellow),  
2) fused crust/agglomerate (orange),  
3) loose debris above (red)  
– location of powder & loose fuel remnants.

**lower crust  
N5-P1-E  
O7-P4**

green labels show samples received by JRC-Karlsruhe under the OECD TMI-2 sample analysis project.

**core bore rocks  
G12-P2-E, G12-P6-E,  
G12-P9-B, G12-P10-A**

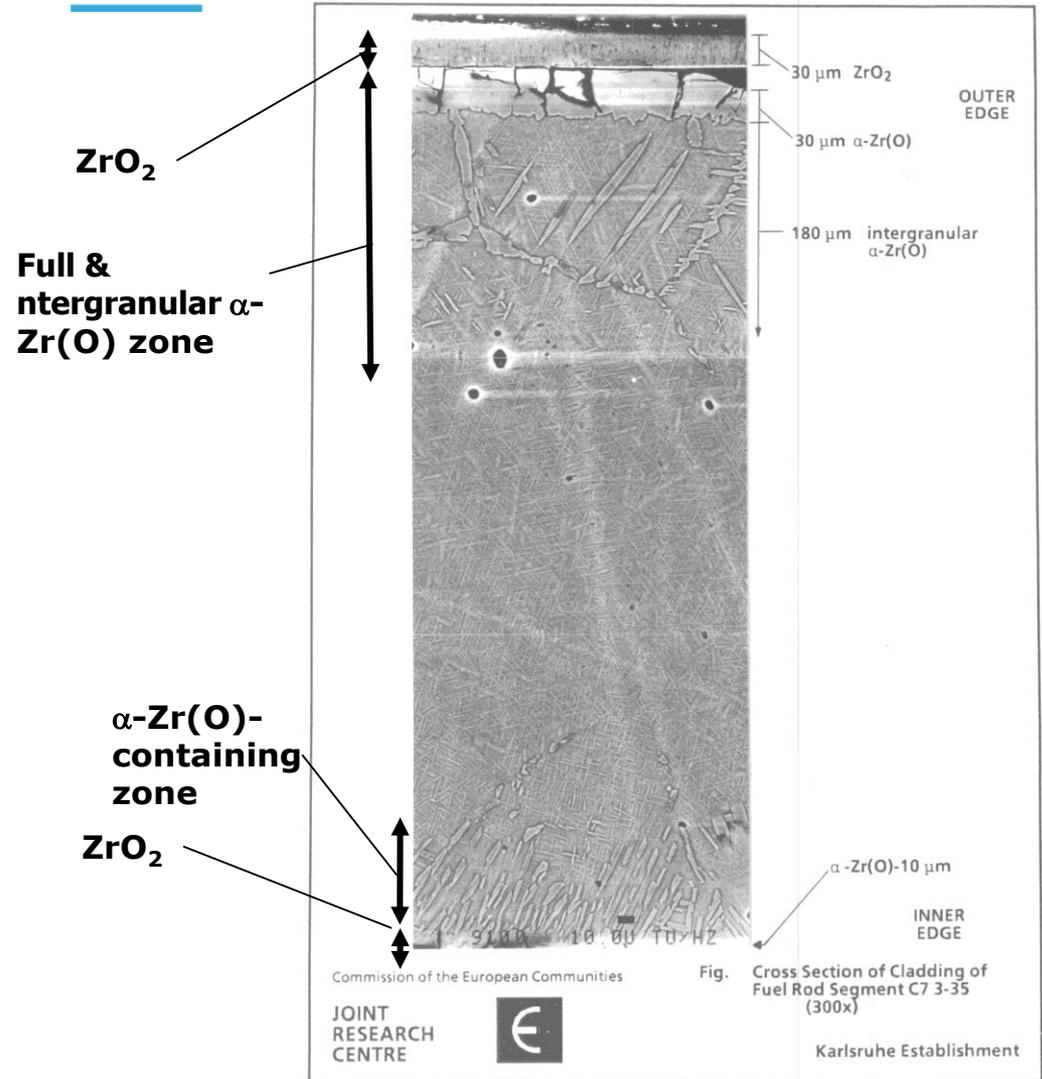
## Cross-section of cladding of fuel rod remnant C7-3-35

**C7-3-35 Fuel rod segment.**  
Note thin external  $ZrO_2$  oxide layer present with  $\alpha$ -Zr(O) containing layers beneath.

**Thin external oxide layers indicate only slight exposure to increased temperatures. (~800C)**

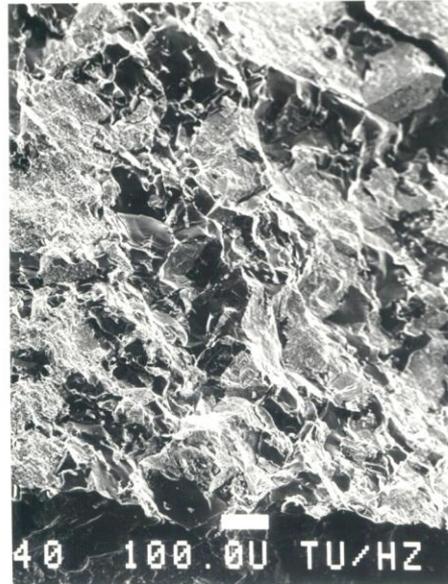
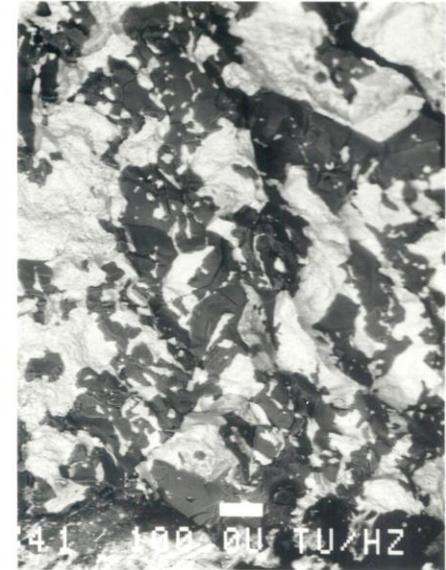
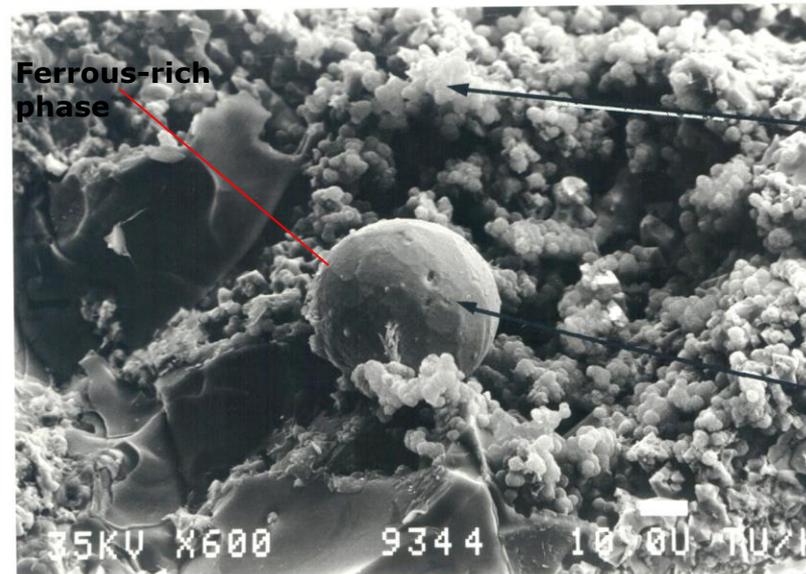
## G12-P9-E Fracture Surface -SEM

a) & b) show dense (U-rich) phases (white) and lighter (Zr-rich) oxide phases (dark)

c) Many fine metallic Ag precipitates on the surface.

Fe-rich oxide phases also present.

a) Secondary Electron Image  
60x mag

b) Back-scattered Electron Image  
60x mag

c) Silver Sphere Precipitate 600x mag

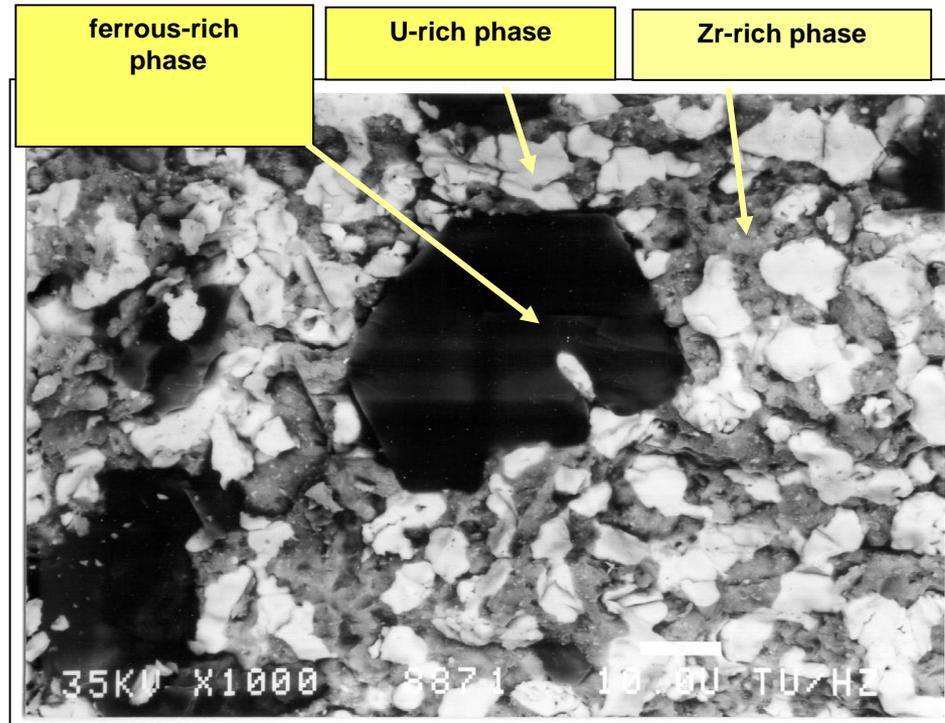
**Core bore rock G12-P9-B**

**Back-scattered image SEM image showing 3 phases in the fully molten rock:**

- dense or white (U-rich) phases;
- less dense (grey) (Zr-rich) phases;
- light element (dark) Fe, Ni, Cr-containing phases

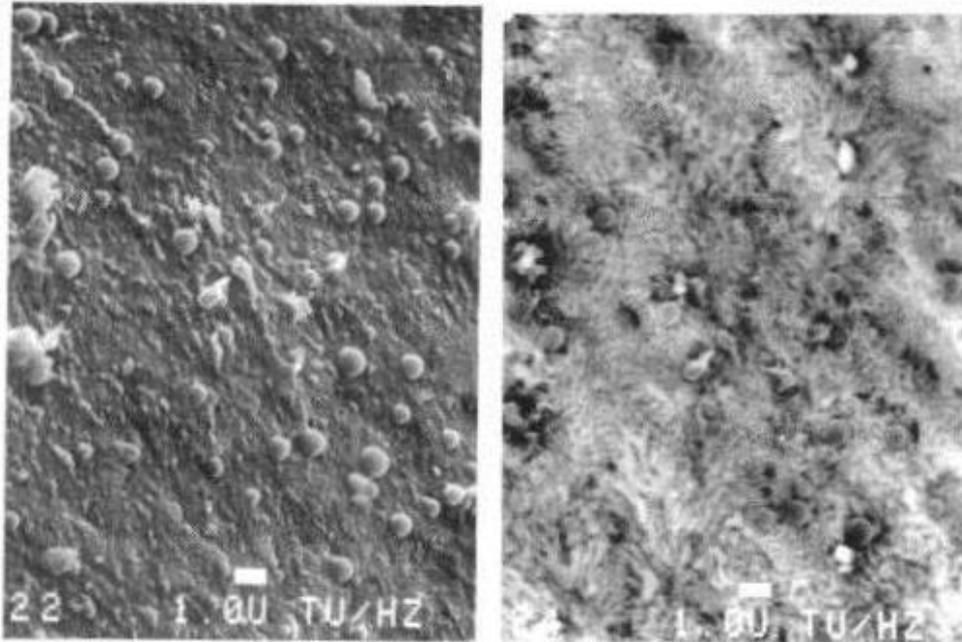
**G12-P10-A fracture surface a) secondary & b) backscattered images. (2760x)**

**Note a) fine eutectic lamella approx. 0,5 $\mu$ m wide (to estimate cooling rate); b) small spheres are Ag spheres from Ag-In-Cd absorber**

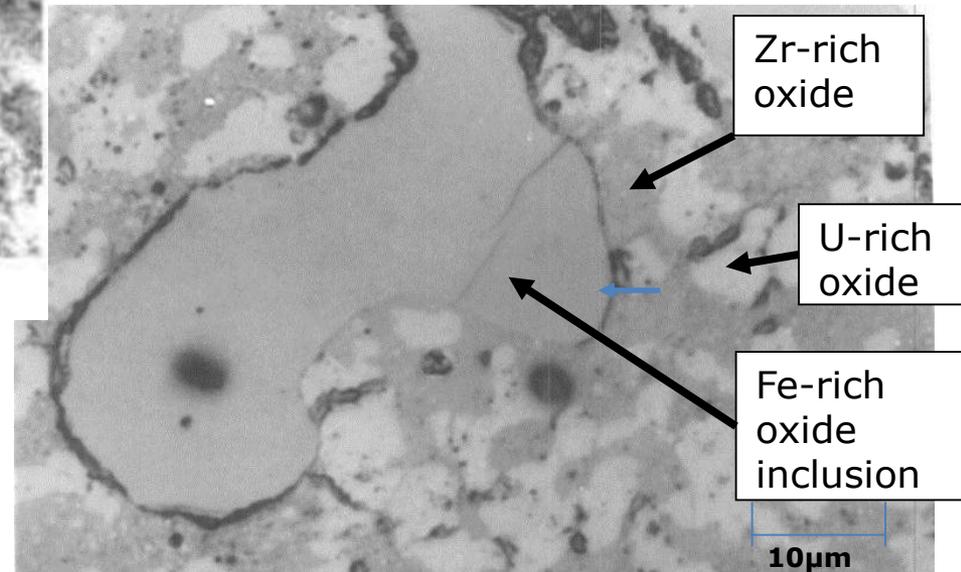
**G12-P2-E (Mag.  $\sim$ 900x) 2-phase corium, lighter U-rich oxide & darker, Zr-rich oxide + Fe inclusion. matrix composition was approx. equimolar (U,Zr)O<sub>2</sub>**

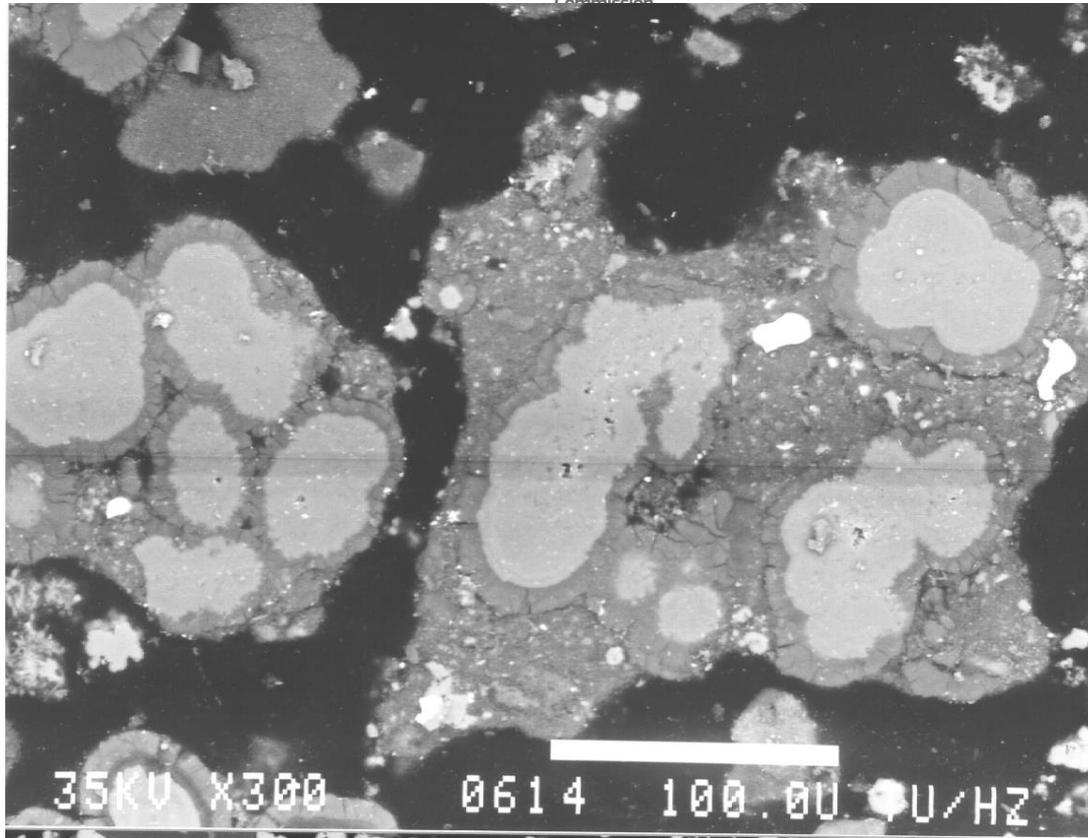
## **Agglomerate crust O7-P4-EA**

**Fe-Ni nodules with pure Fe metallic core (lighter centres) surrounded by Fe-Ni oxide crust (darker zones) due to preferential oxidation (BEI-1000x)**

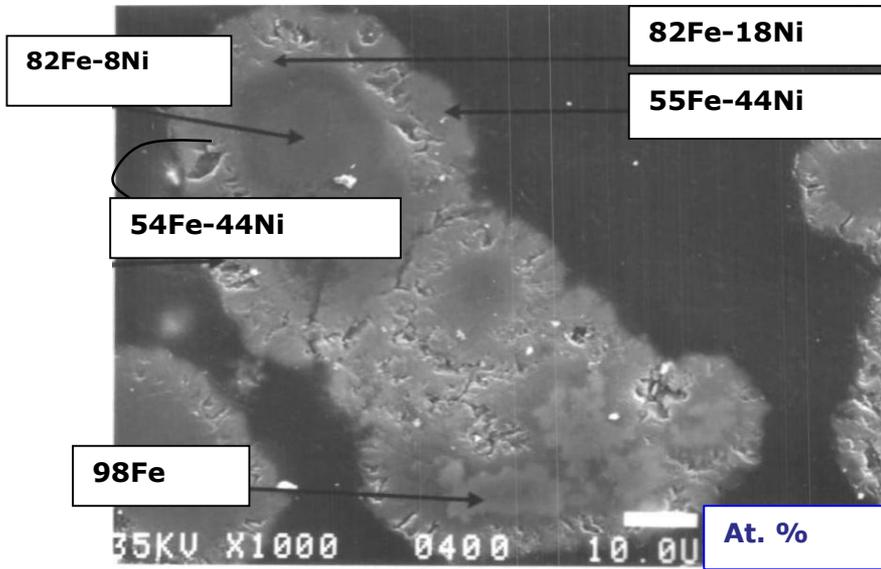
SEM image of an agglomerate sample from O7-P4-E zone of the lower crust.

- a Fe-Ni nodule is seen with a Ni-rich oxide layer on the outside
- example of preferential oxidation of the Ni (intermediate oxygen levels)

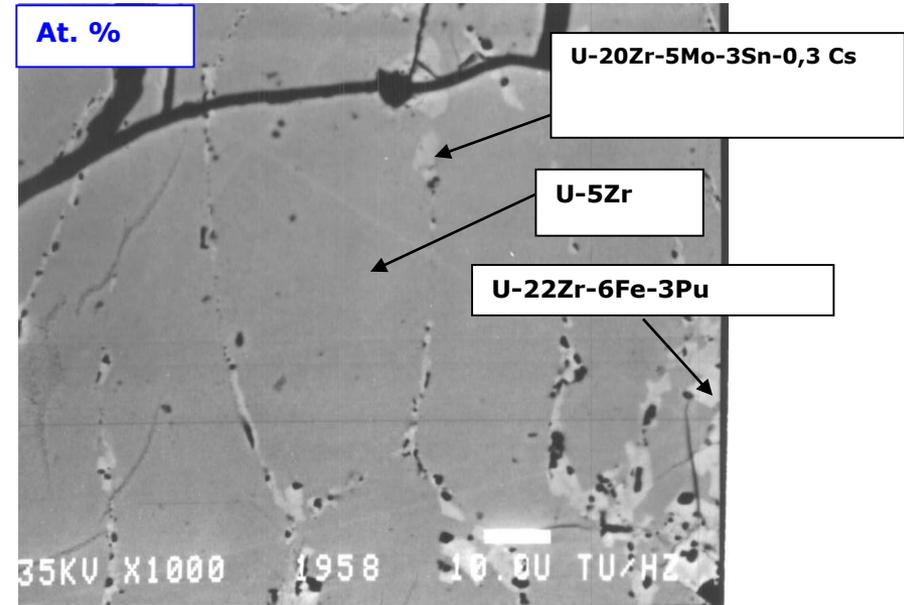
Backscattered electron SEM image of an upper crust (or agglomerate) sample D8 P3-A.

- Elements of fuel, cladding & structural material are seen.
- There are wide grain boundaries (containing eg. Zr & Fe) in U-rich grains.
- This shows gradual material interactions indication of lower temperatures than core

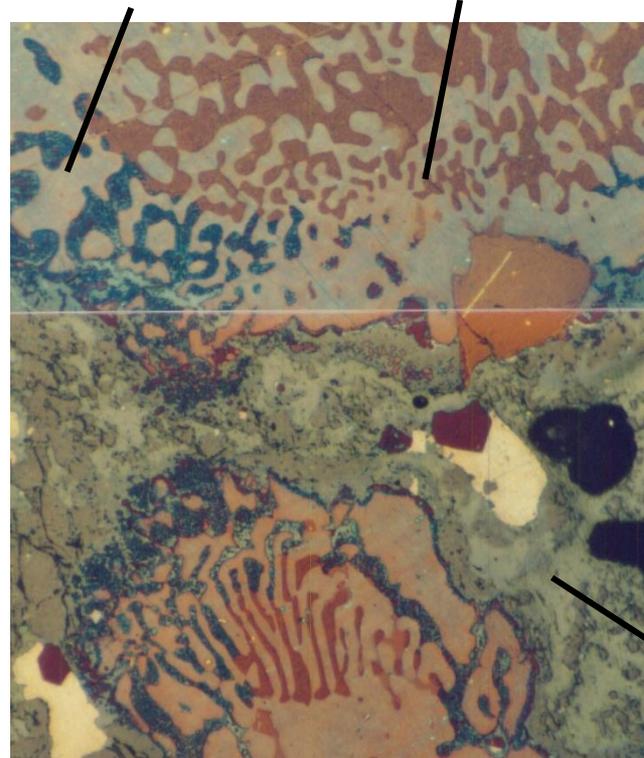
**D8-P3-A Agglomerate sample (190x) interference micro showing metallic and oxidic zones, both with secondary phases.**

**Indicates incomplete interactions - lower temperatures or lower durations at a temperature**

**2 phase metallic /oxidic zone**      **2 phase metallic zone**

**Oxidic zone with some secondary precipitates**

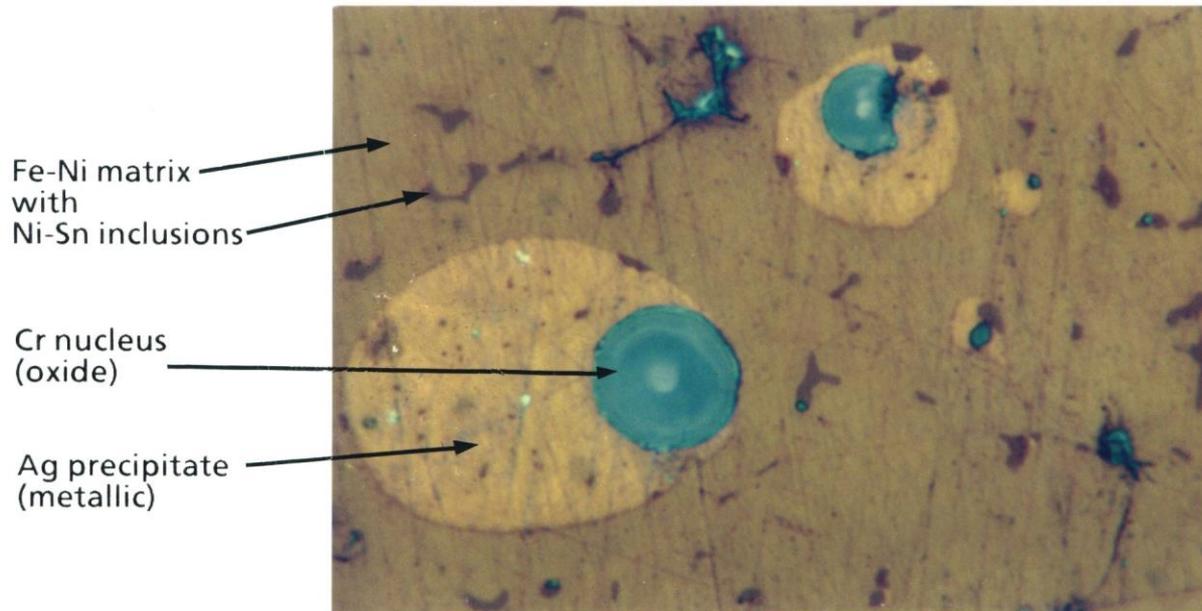
### Agglomerate N5-P1-E (1033x).

b) Interference Micrograph (1033x)

(CuO vapour coating)

Stainless steel control rod cladding with Ag spheres that contain Cr oxide nuclei.

A metallic-dominated phase from a control rod

$\rho \sim 6.7 \text{ g/cm}^3$  (compared to steel  $\rho = 7.93 \text{ g/cm}^3$ ) implies it is steel dominated.

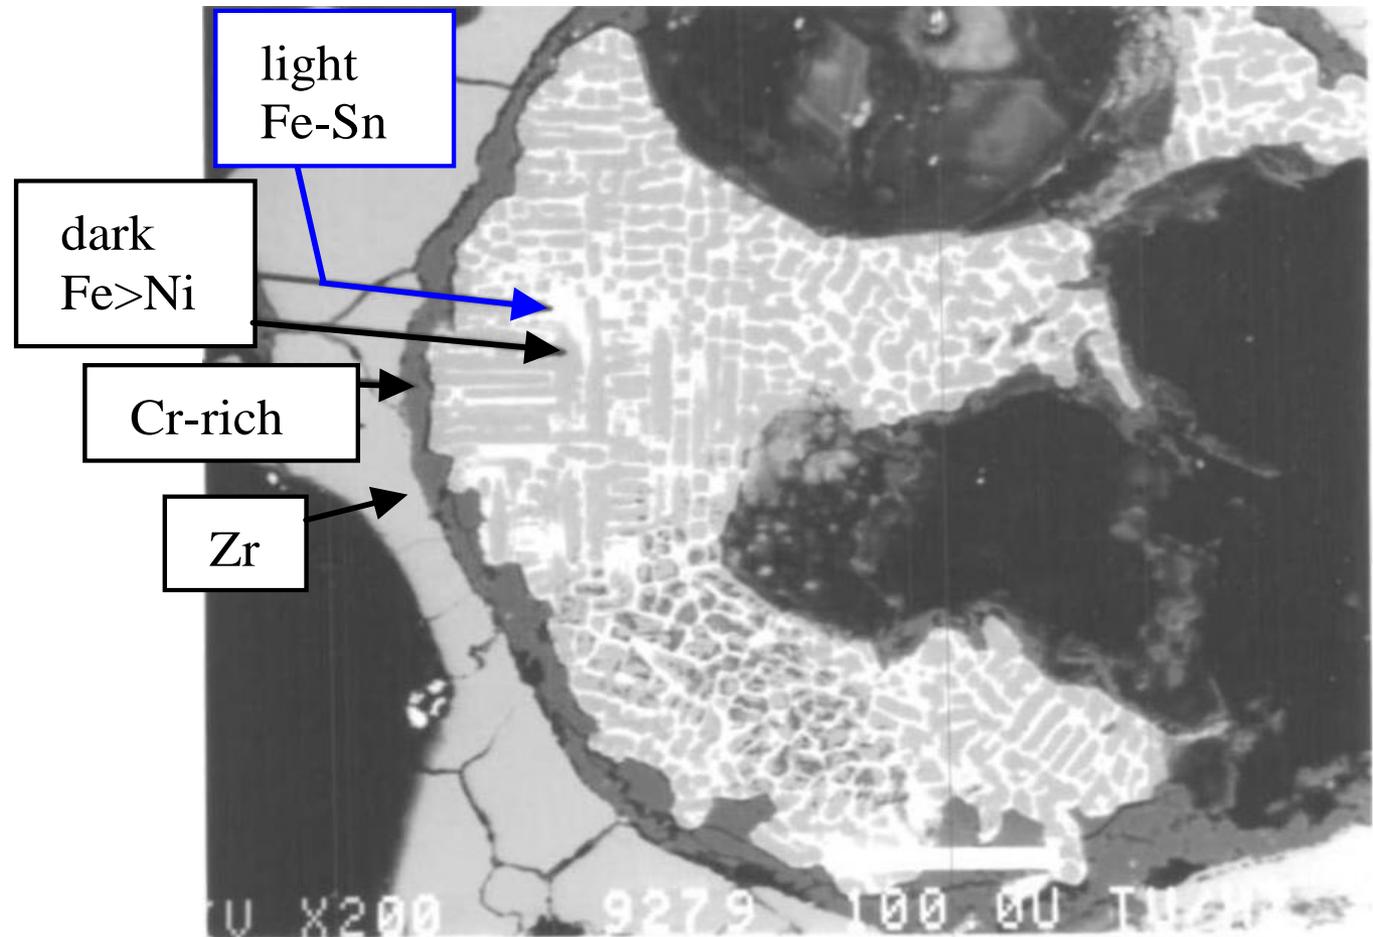
## H8 7-3 from above the upper crust - BEI of a debris sample

- Note nodule with a lamellar structure of Fe
- Ni & Fe-Sn phases surrounded by a Cr-rich layer.
- Nodule itself is surrounded by Zr.
- Fe Fe-Ni & Fe-Sn phases have a lustrous metallic appearance.

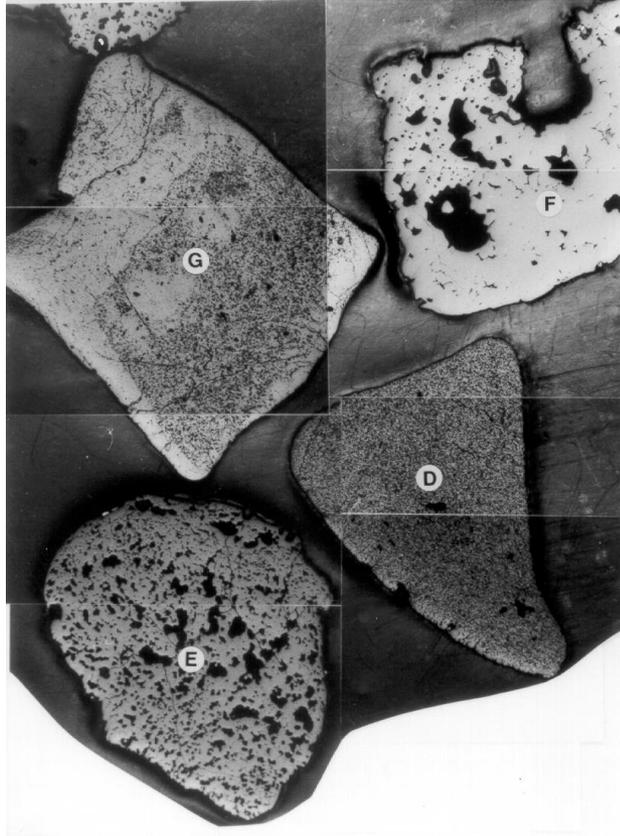
**Macroscopic photo of various debris pieces (approx. 5x)**

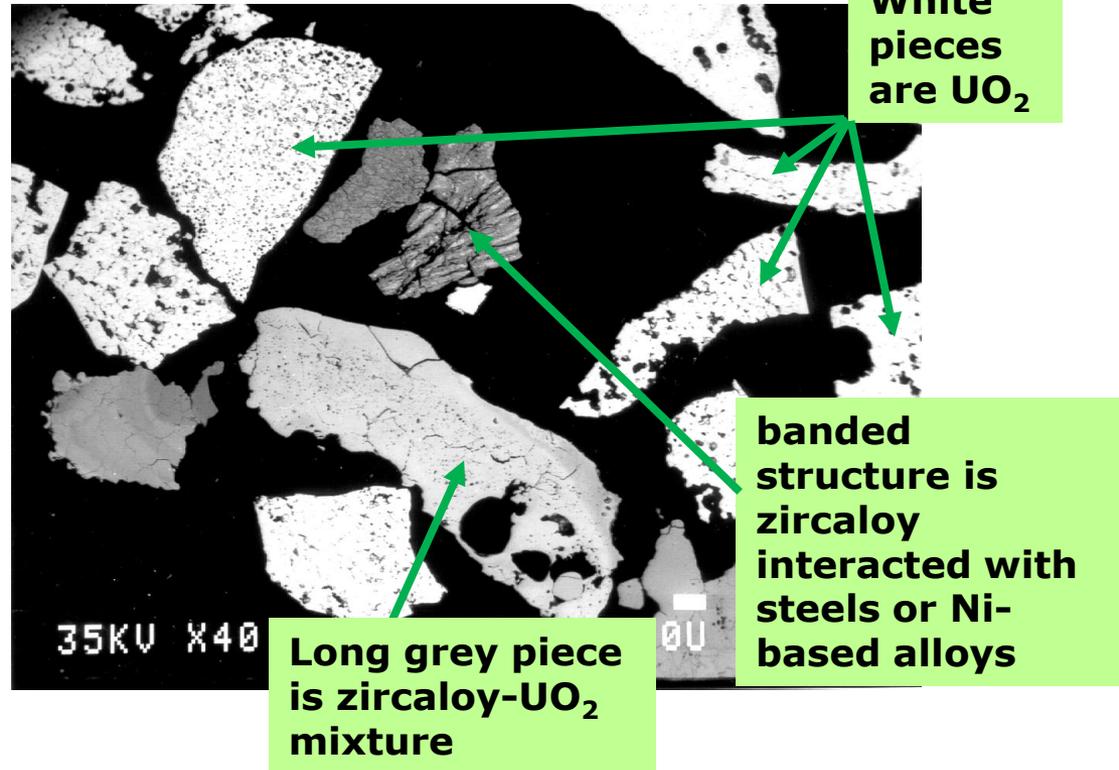
**Debris H8-7-5-1 located on the upper agglomerate (40x)**

**Note variety of debris particles: unchanged UO<sub>2</sub> fuel particles & cladding, oxidised cladding fused cladding, steel -cladding intractions. Particles have different origins and histories, and have suffered different temperatures**

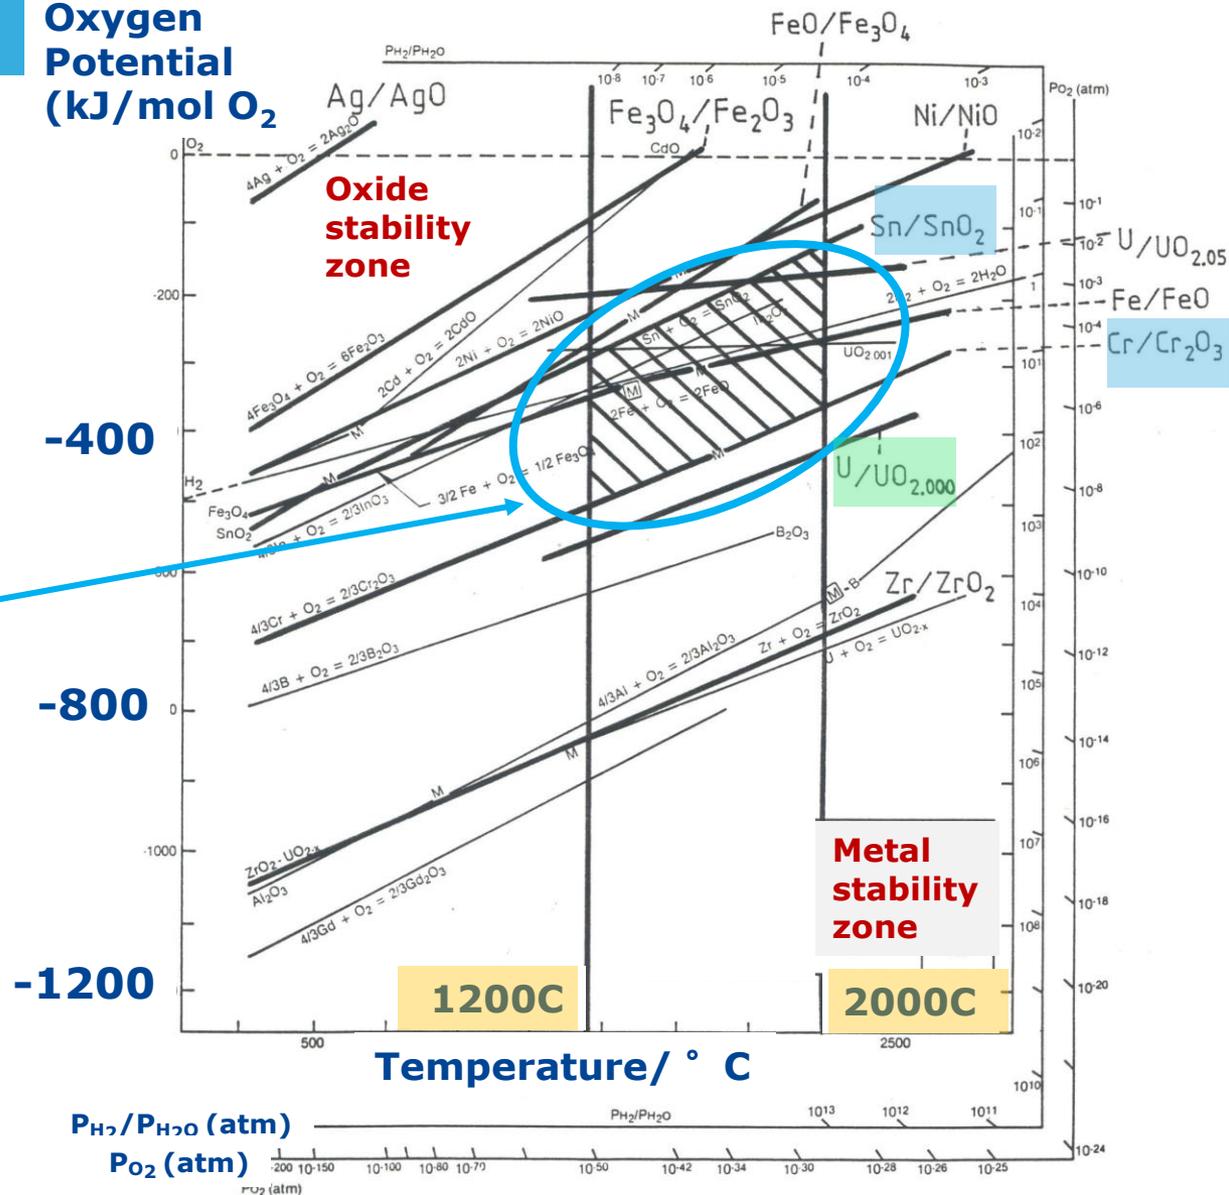
# TMI-2 Ellingham Diagram of samples

Oxygen Potential (kJ/mol O<sub>2</sub>)

Range of oxygen potential observed in core bore rocks & agglomerate zones

This gives an indication of the conditions (T and P<sub>O<sub>2</sub></sub> or P<sub>H<sub>2</sub></sub>/P<sub>H<sub>2</sub>O</sub>) in the reactor for the central rocks and surrounding agglomerate zones

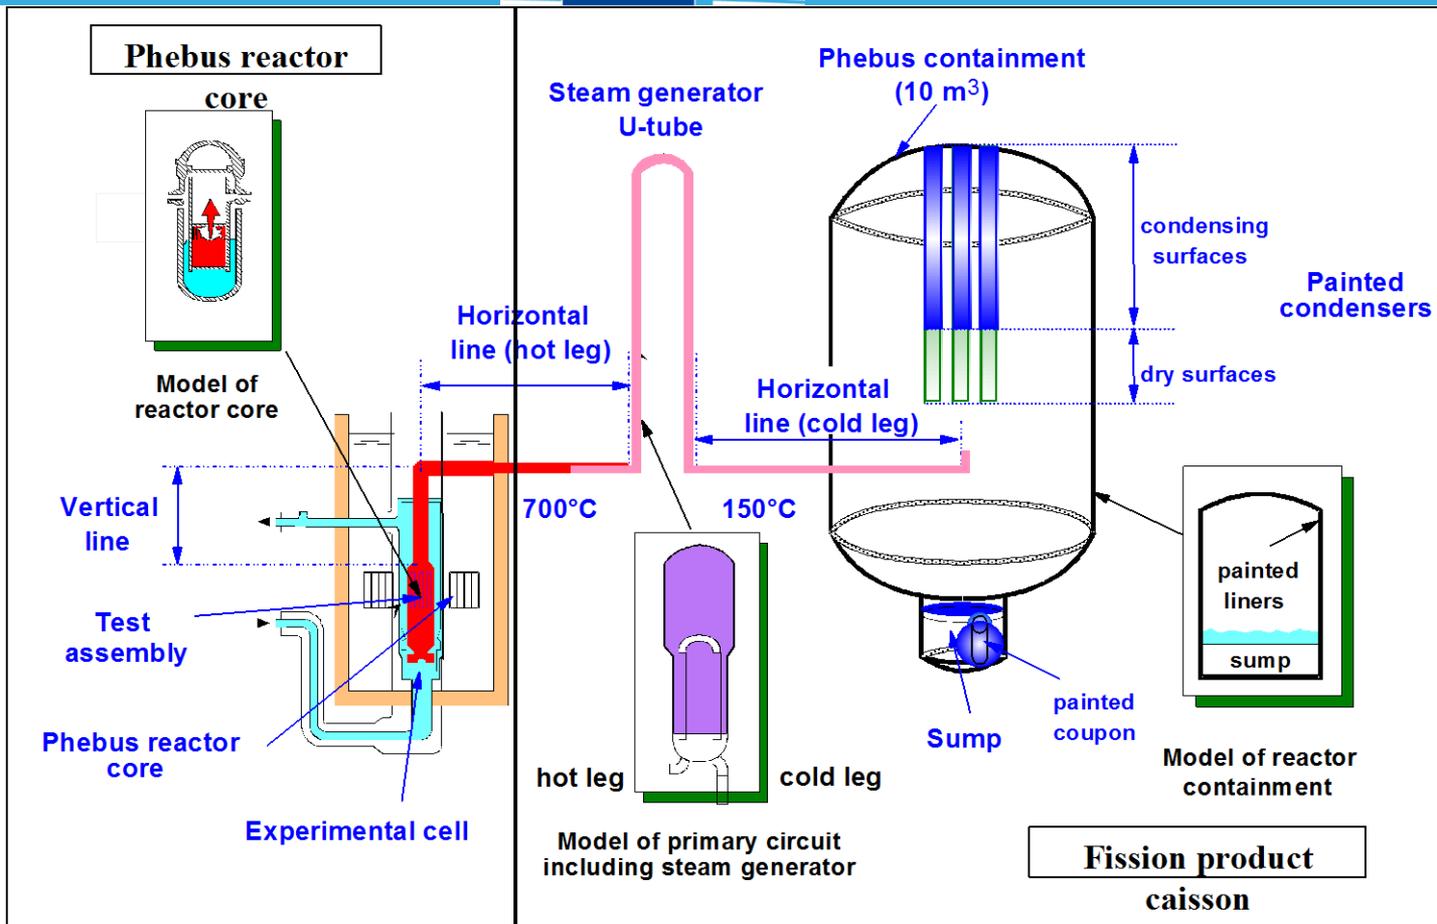
## Phébus PF Facility

**Phébus FP (fission product) with a driver core, test bundle and vertical line leading to the simulated primary circuit. The circuit has a horizontal line with a simulated steam generator before the airborne fission products pass into a containment tank & a sump to collect liquids.**

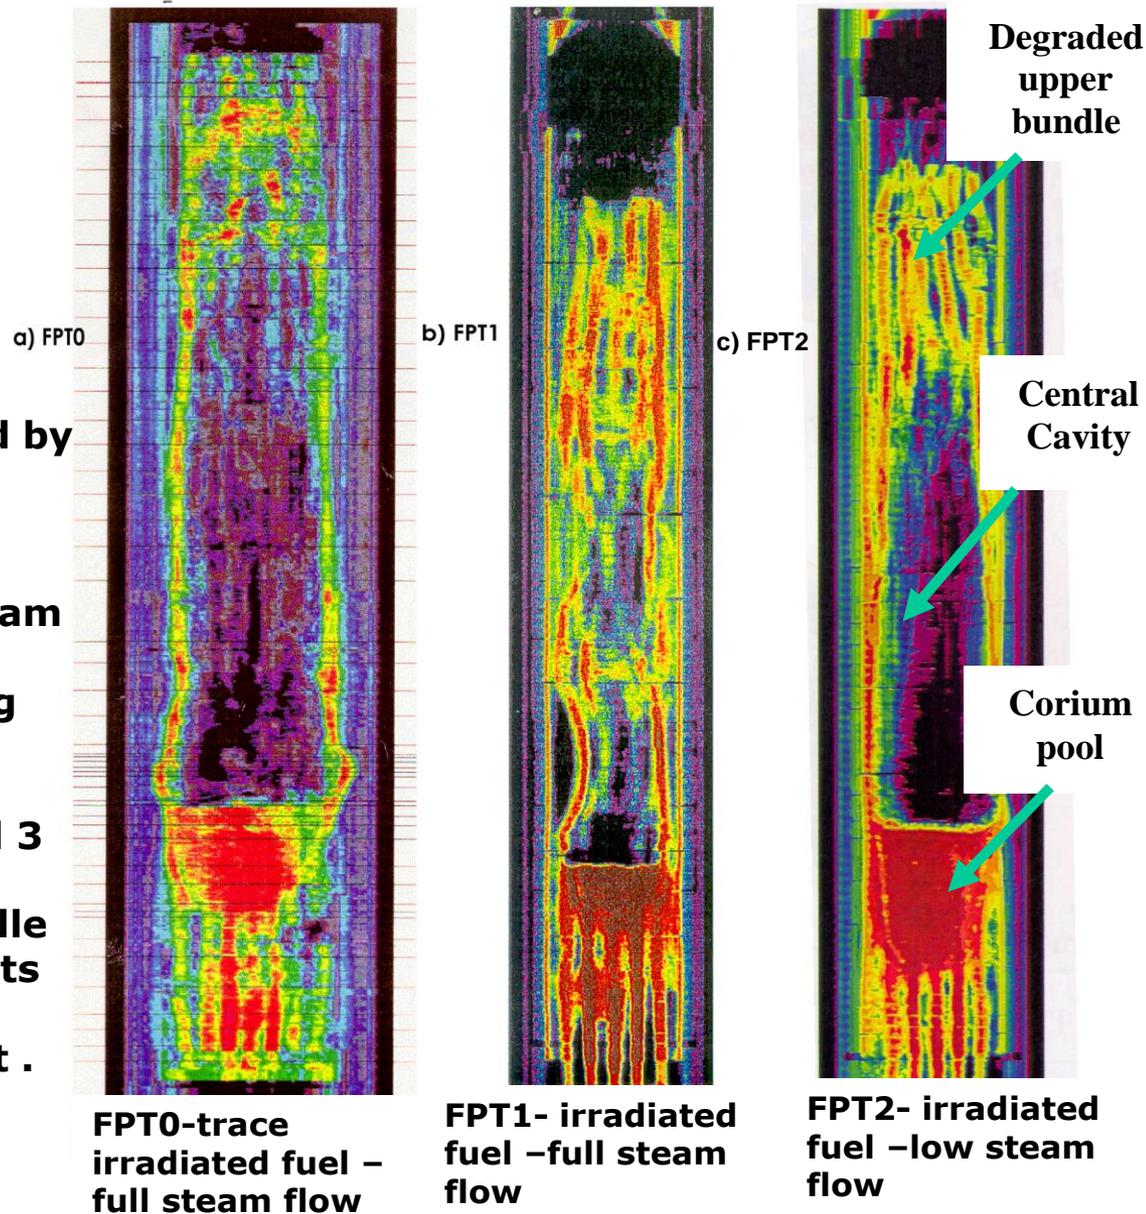
X-ray tomographic scans produced by IRSN directly after testing:

- a) FPT0 (trace (8day) irradiated fuel),
- b) FPT1 (2yr irradiated fuel) & steam flow
- c) FPT2 (low steam flow- reducing conditions).

Degradation results common to all 3 tests:

- a) an heavily-oxidised upper bundle
- b) melting of hot central zone & its relocation to produce :
- c) a corium pool at quarter-height .

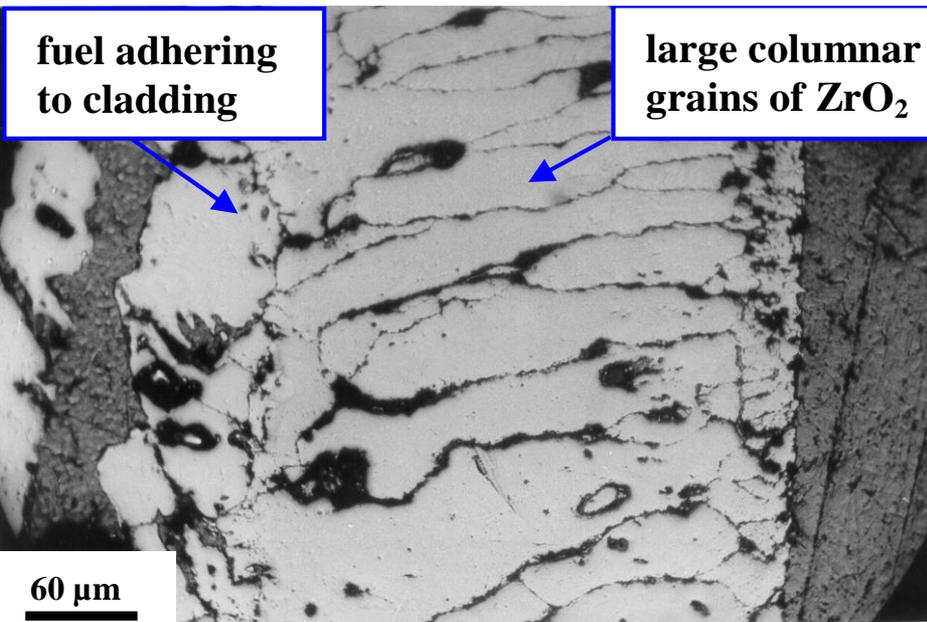
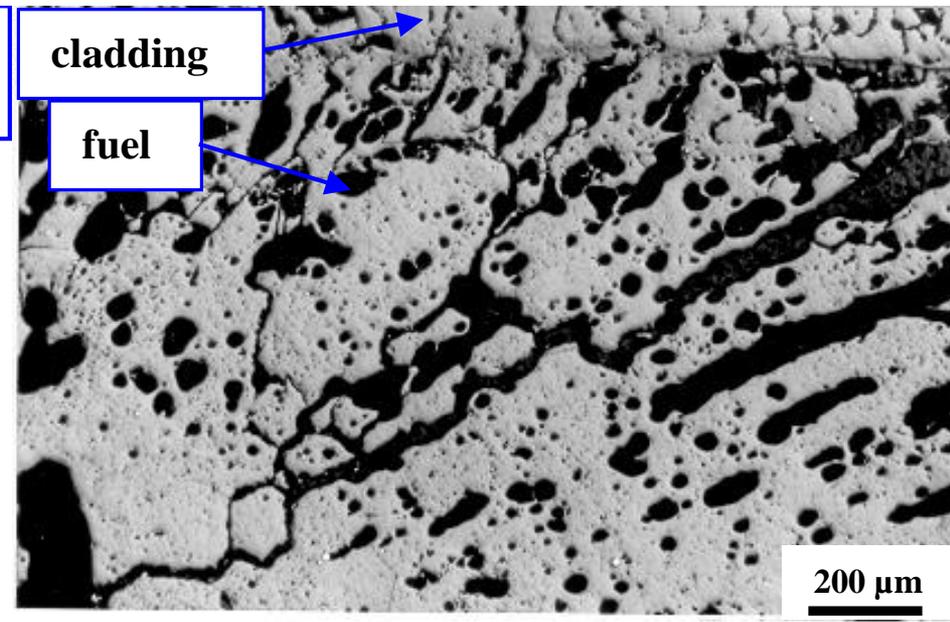
## Upper Phébus bundle (FPT1)

**Micrograph of fully oxidised cladding from a fuel rod at +607 mm height of FPT1 bundle.**

**Micrograph of degrading irradiated fuel at the +607mm height of the FPT1 bundle  
- lenticular porosity due to fission gas bubble movement in overheated fuel.**

**Note heavily oxidised cladding and degraded fuel, in semi-liquified condition**

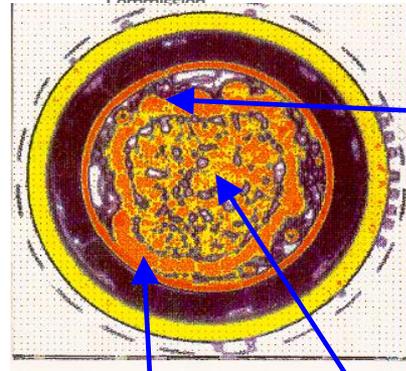
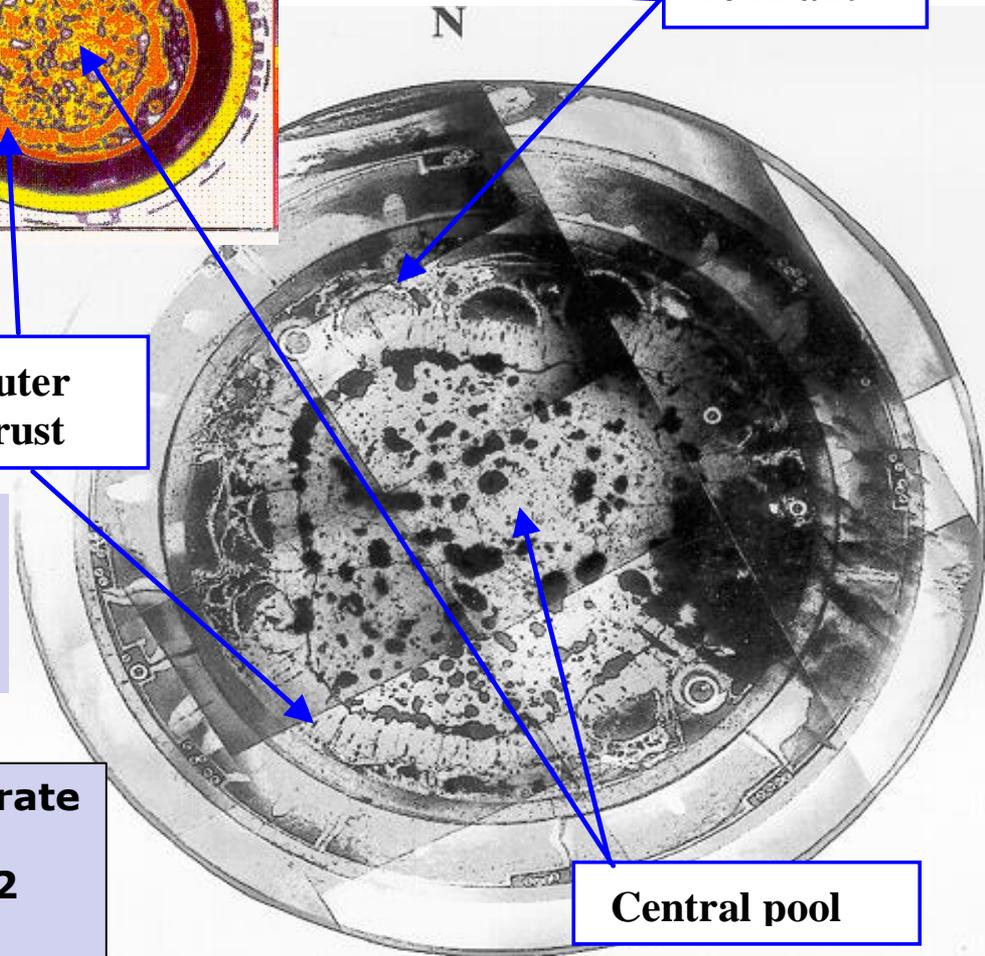
## Corium Pool PIE

Comparison of the corium pool of  
FPT1 bundle at +228mm height  
(from bundle bottom) with the  
tomography for the same position.

outer  
crust

Fuel rod  
remnant

Central pool

Corium pools compositions of FPT0, FPT1  
& FPT2: U/Zr atomic ratio= 1.06 to 1.44  
TMI-2 core (G12-P 9-B) U/Zr estd. at 1.18

- Non-destructive tomography is very accurate  
- Corium pool composition reasonably  
consistent between Phébus tests and TMI-2  
data

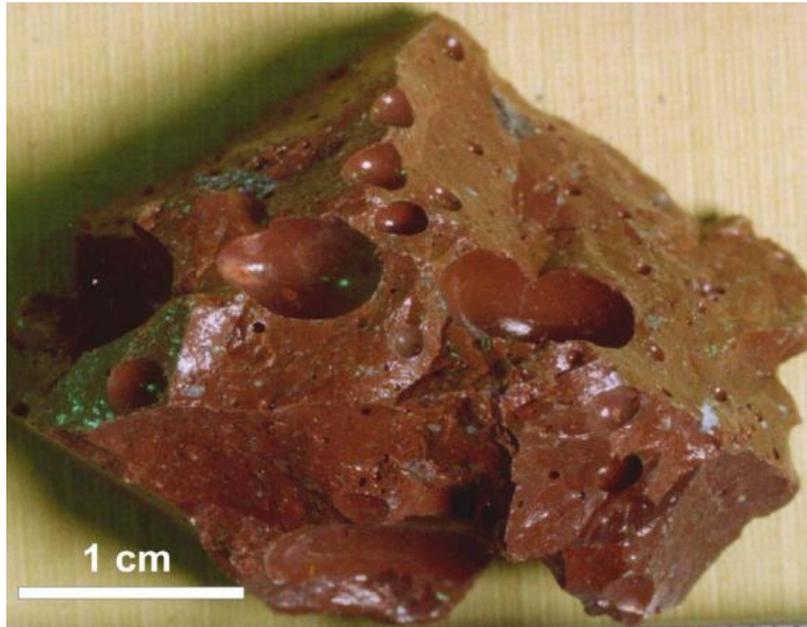
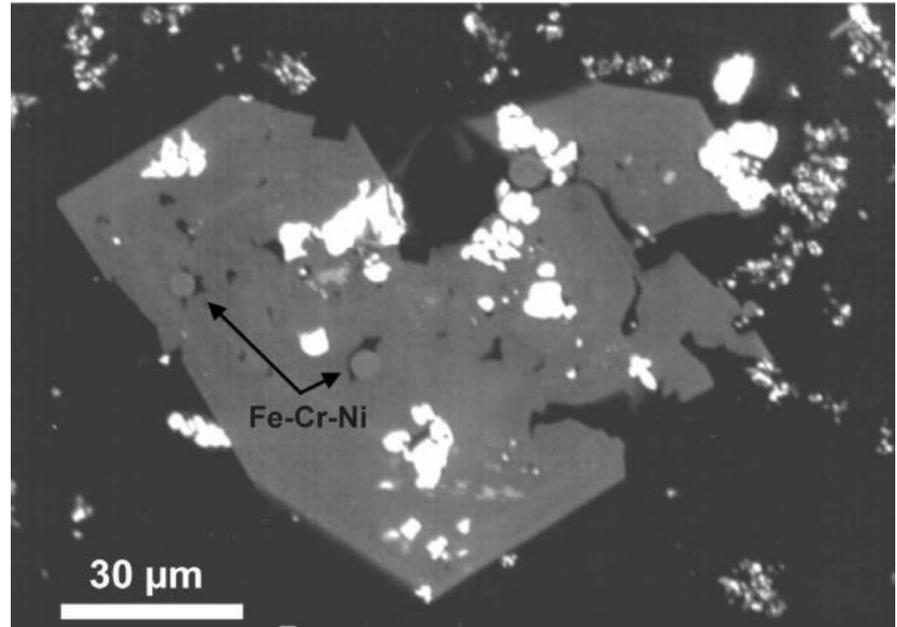
**Sample of brown lava and SEM micrograph of crystal structures found in this lava sample. The highly dense (white) phases are U-rich fuel particles in a poly-phase matrix.**

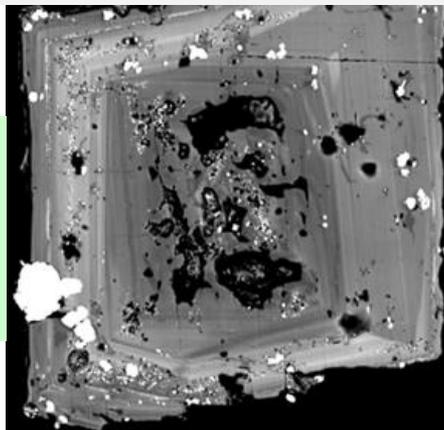
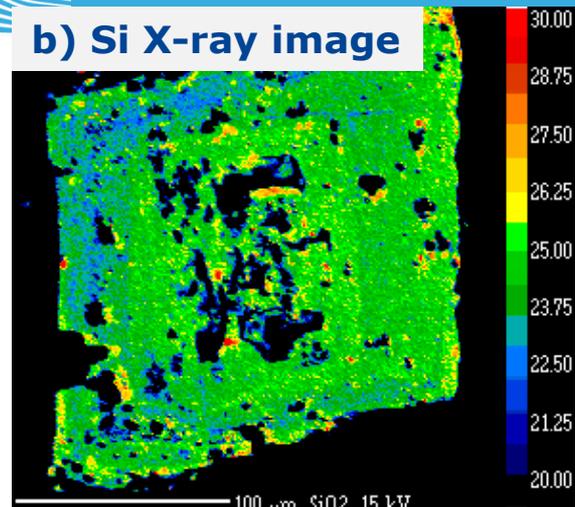
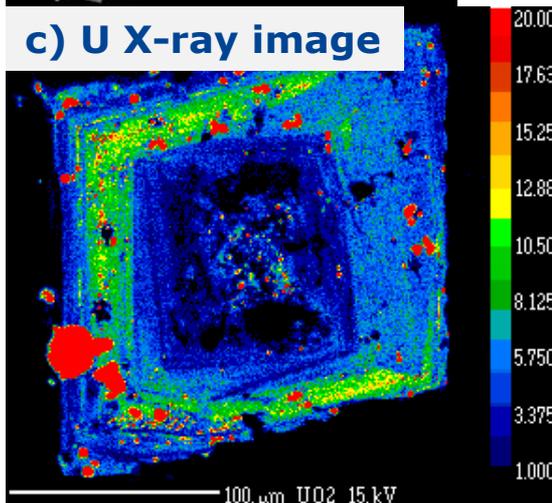
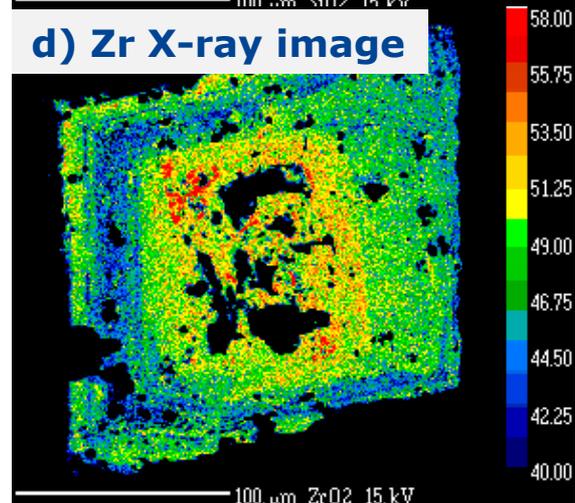
a) secondary electron image

b) Si X-ray image

c) U X-ray image

d) Zr X-ray image

Backscattered  
image of U  
zircon crystal  
with inclusions.

- X-ray image mapping shows the layered compositions during slow cooling to form a U-rich centre and Zr & Si-rich outer edge.
- This can be used to determine its temperature as it solidified. This data can be used to validate lava flow models and to understand the conditions of the accident
