Estimation of current status inside RPV and PCV at Fukushima daiichi NPS

July 3, 2017

Tokyo Electric Power Company
Holdings, Incorporated
Shinya Mizokami

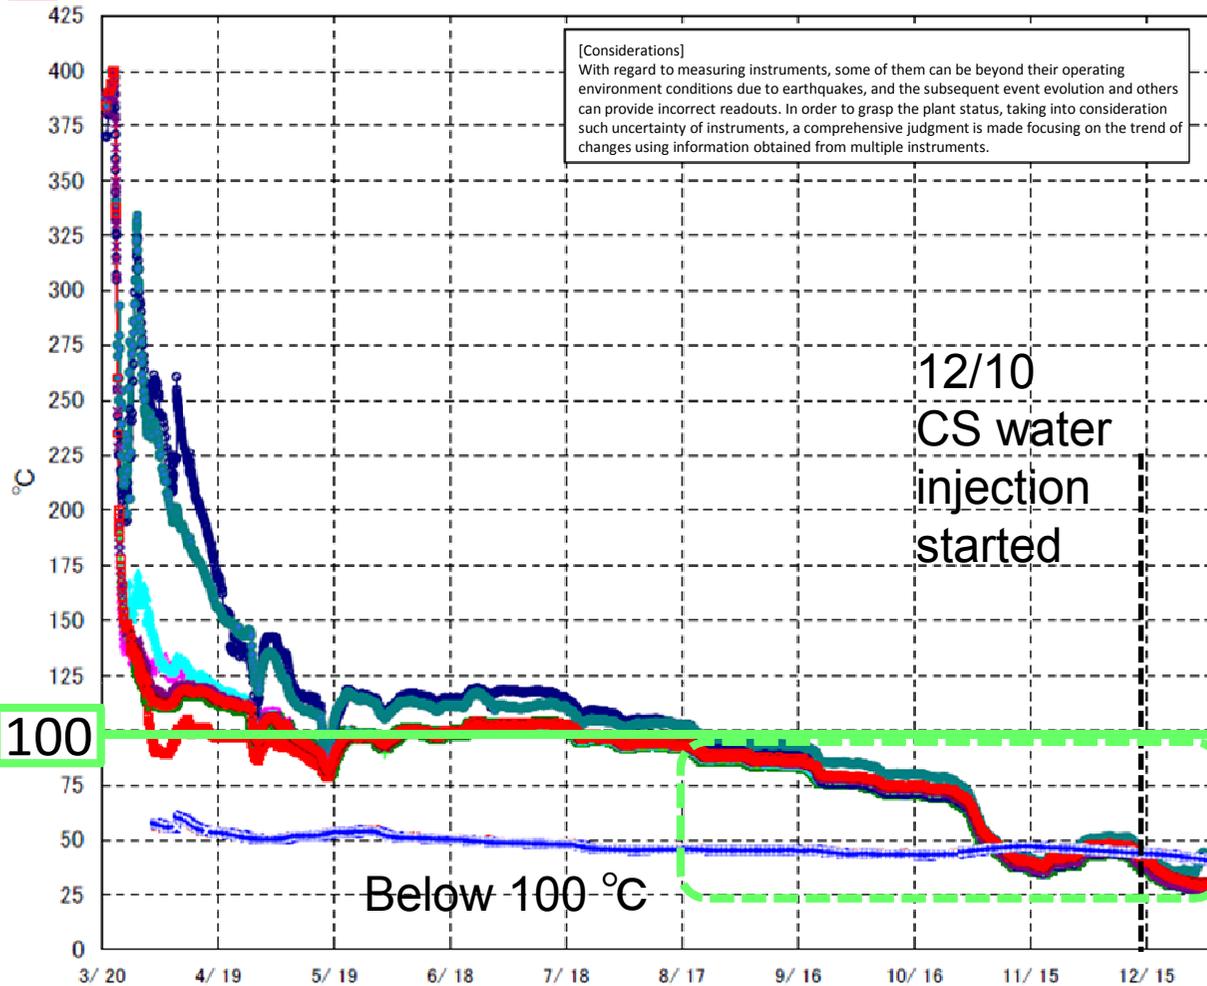
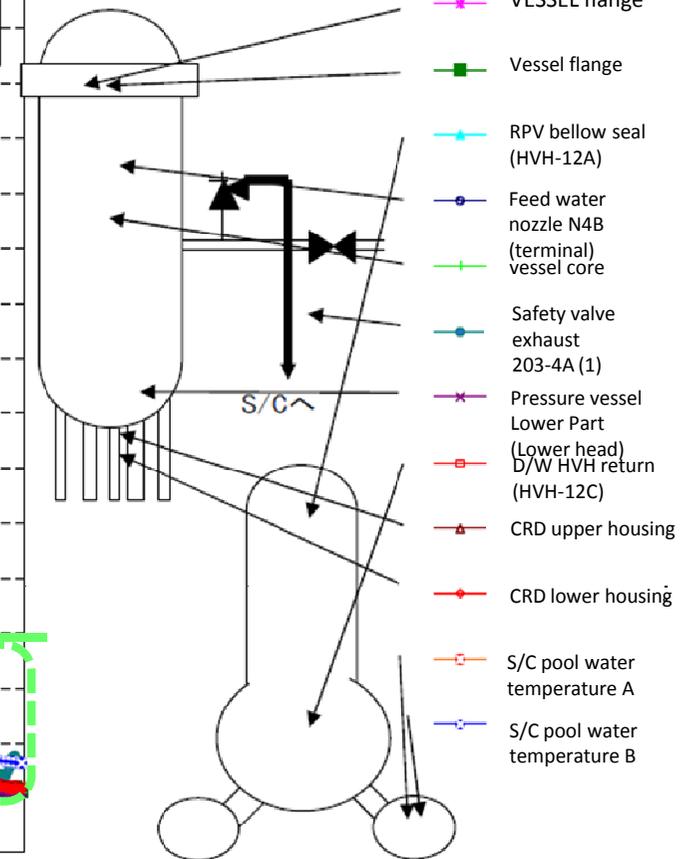
For Unit 1, water injection from CS system started on December 10, 2011. Before that, however, most of the observation points in the containment vessel fell below 100 °C. Therefore, estimated that almost no fuel remains in the core.

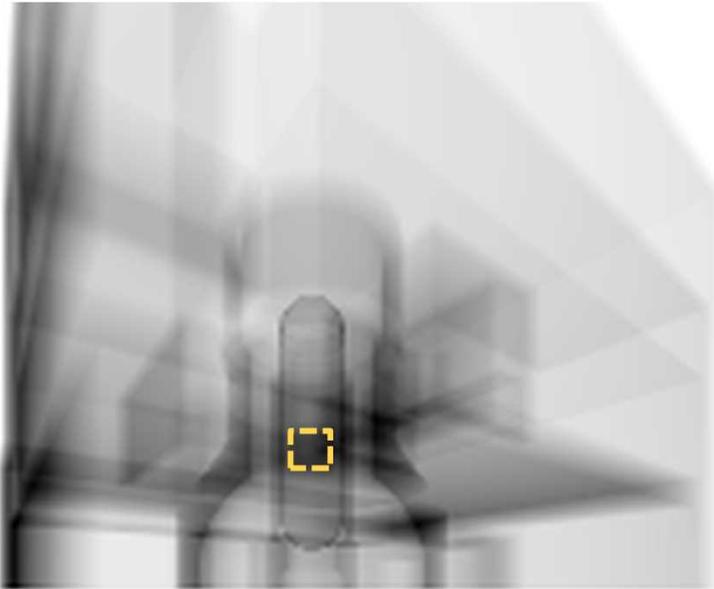
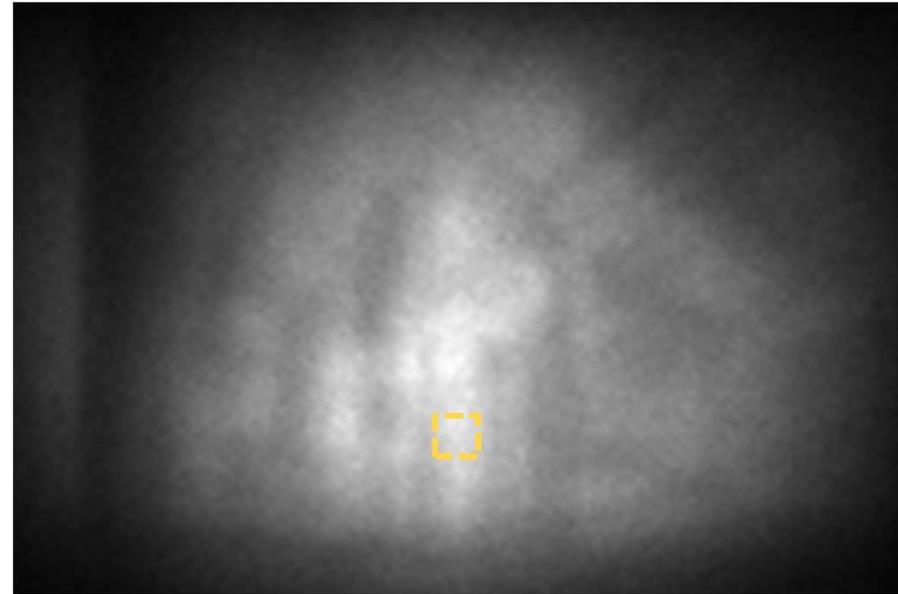
Image of estimated muon measurement result based on design drawing (Area enclosed by a broken line shows the core)

Image of muon measurement using 96 days' worth of data (Area enclosed by a broken line shows the core)

High-absorbent objects (except for fuel) such as pressure vessel walls, containment vessel walls, and reactor building walls can be confirmed by muon measurements. (Measurement period: February 9 to May 21, 2015)
Meanwhile, no large fuel mass exceeded 1 m in the core (resolution of the measurement).
⇒ **Estimated that almost no fuel remains in the core.**

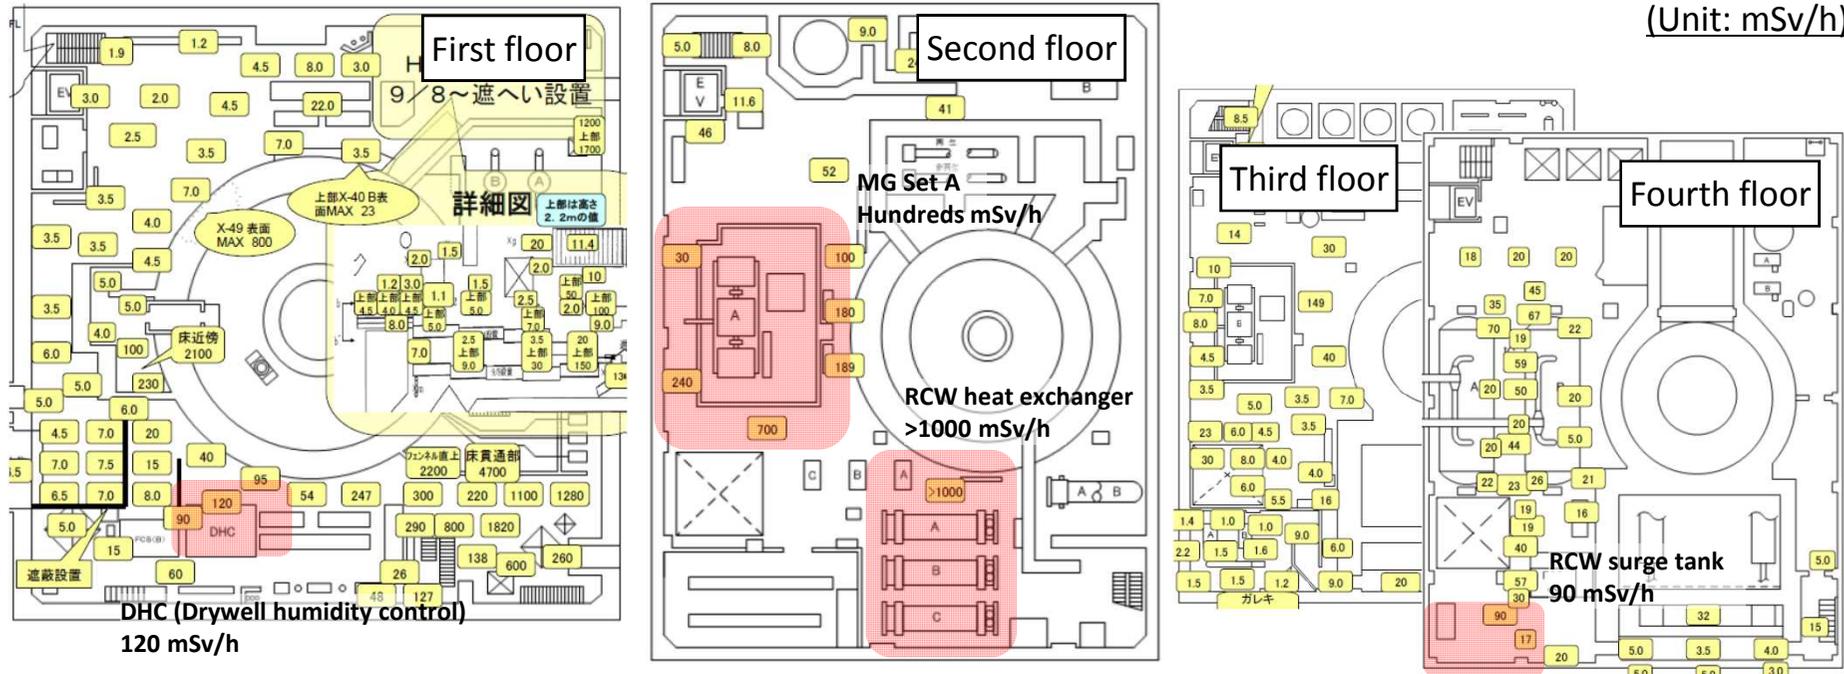
RCW system is a closed loop* and unlikely to experience high dose contamination in normal conditions. However, high dose was observed around equipment to be cooled by RCW over multiple floors in the reactor building.

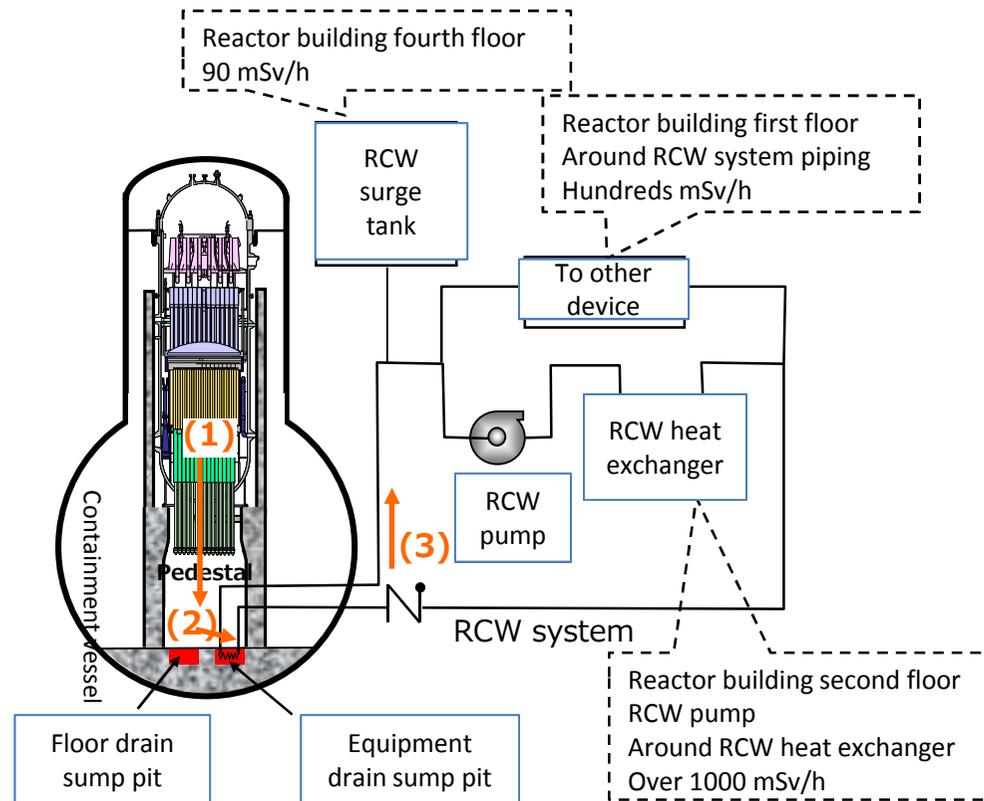
Because RCW system is cooling the equipment drain sump in the pedestal, the contaminants in RCW system are estimated to be:

- (1) Molten fuel fell into the equipment drain sump located in the containment vessel pedestal
- ⇒ (2) Molten fuel damaged RCW piping in equipment drain sump
- ⇒ (3) In Unit 1, with the containment pressure increased significantly during the accident progression, water and steam containing radioactive materials transferred to RCW piping

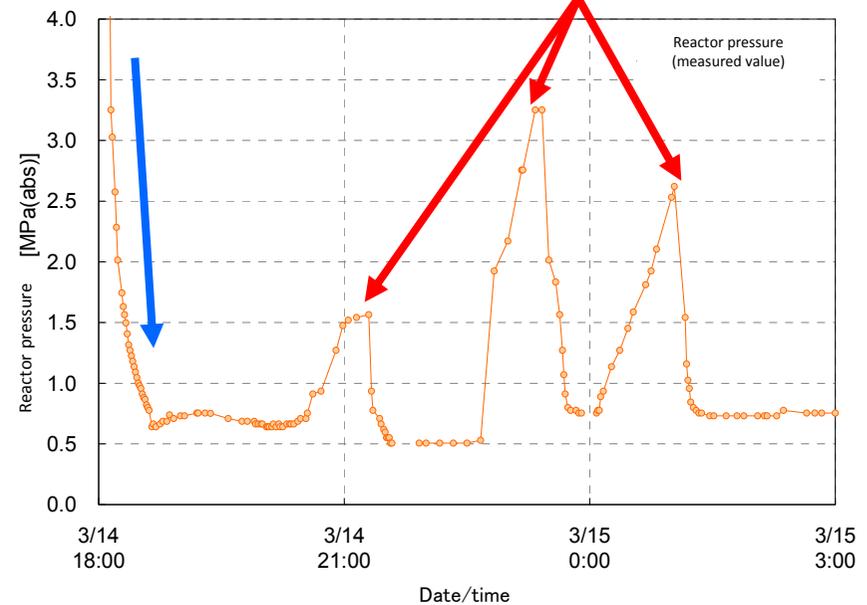
- At Fukushima Daiichi Unit 2, the reactor depressurization was successful upon forced SRV opening at 6:00 p.m. on March 14, but the reactor experienced a pressure rise three times during the period from that night to the next morning.
- This behavior was thought to be related to SRV opening operation (pressure increase = SRV closed, pressure decrease = SRV open). However, this does not directly show the open/close state of SRV.
- Along with this pressure increase, an increase in the containment vessel pressure associated with hydrogen has been confirmed, and this pressure increase is greatly related to the accident progression in Unit 2.

Understanding this behavior is extremely important in understanding the accident progression and core status of Unit 2

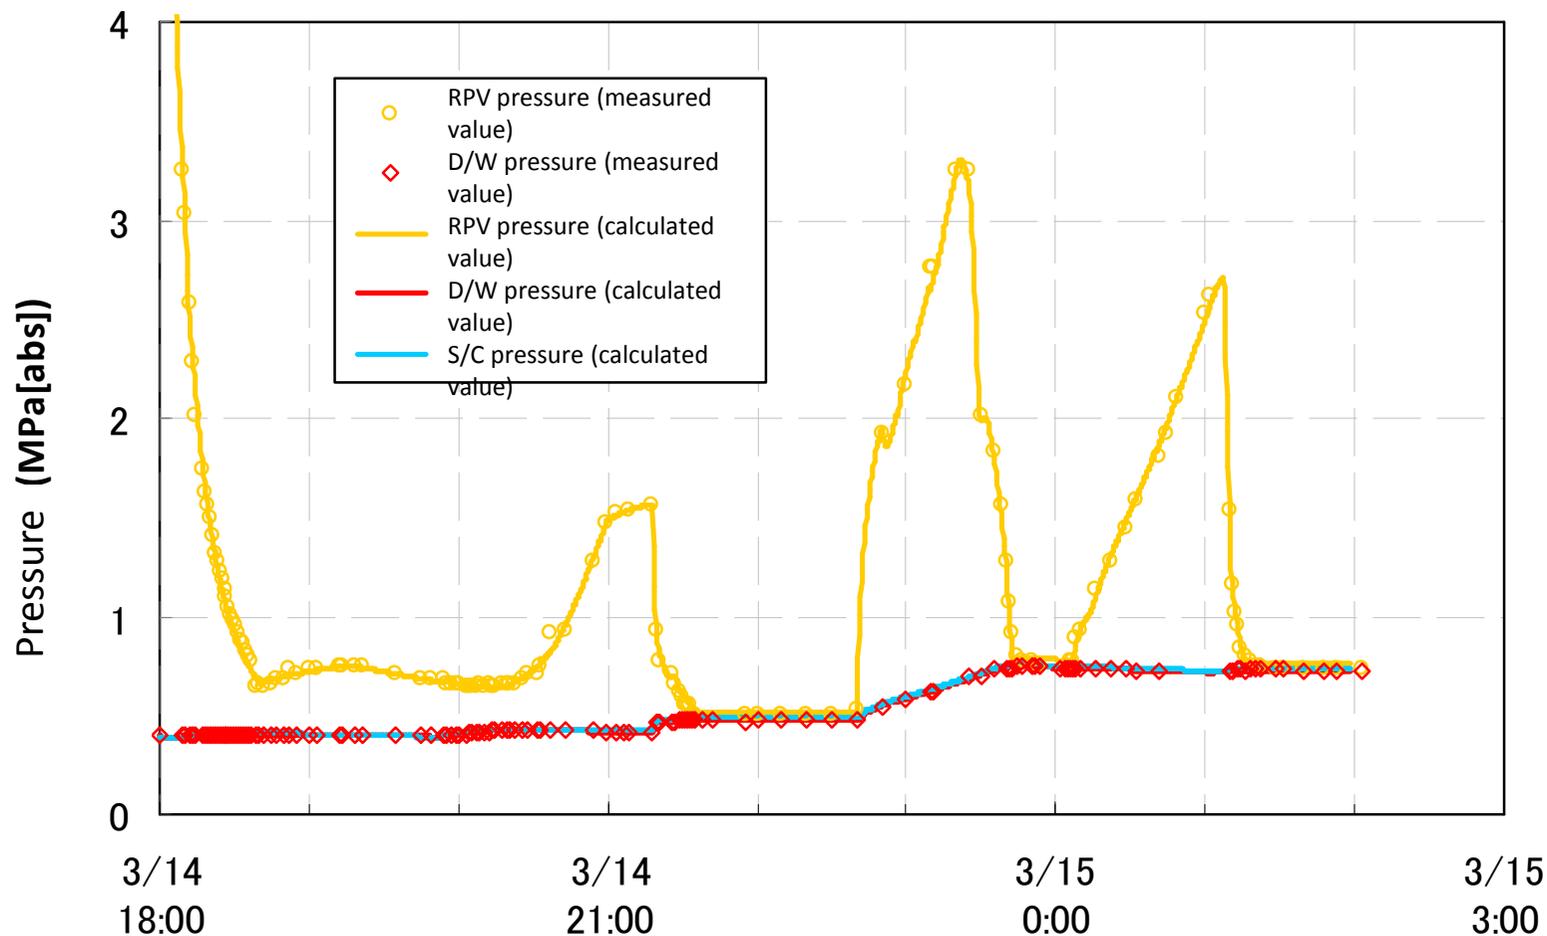
- Adjusting the generation amount of steam and hydrogen by GOTHIC (Generation of Thermal Hydraulic Information in Containment) that is the general flow analysis code successfully reproduced the RPV pressure and PCV pressure.
- Assumed semi-opening (40%) of SRV to reproduce the RPV/PCV pressure behavior at the second peak.

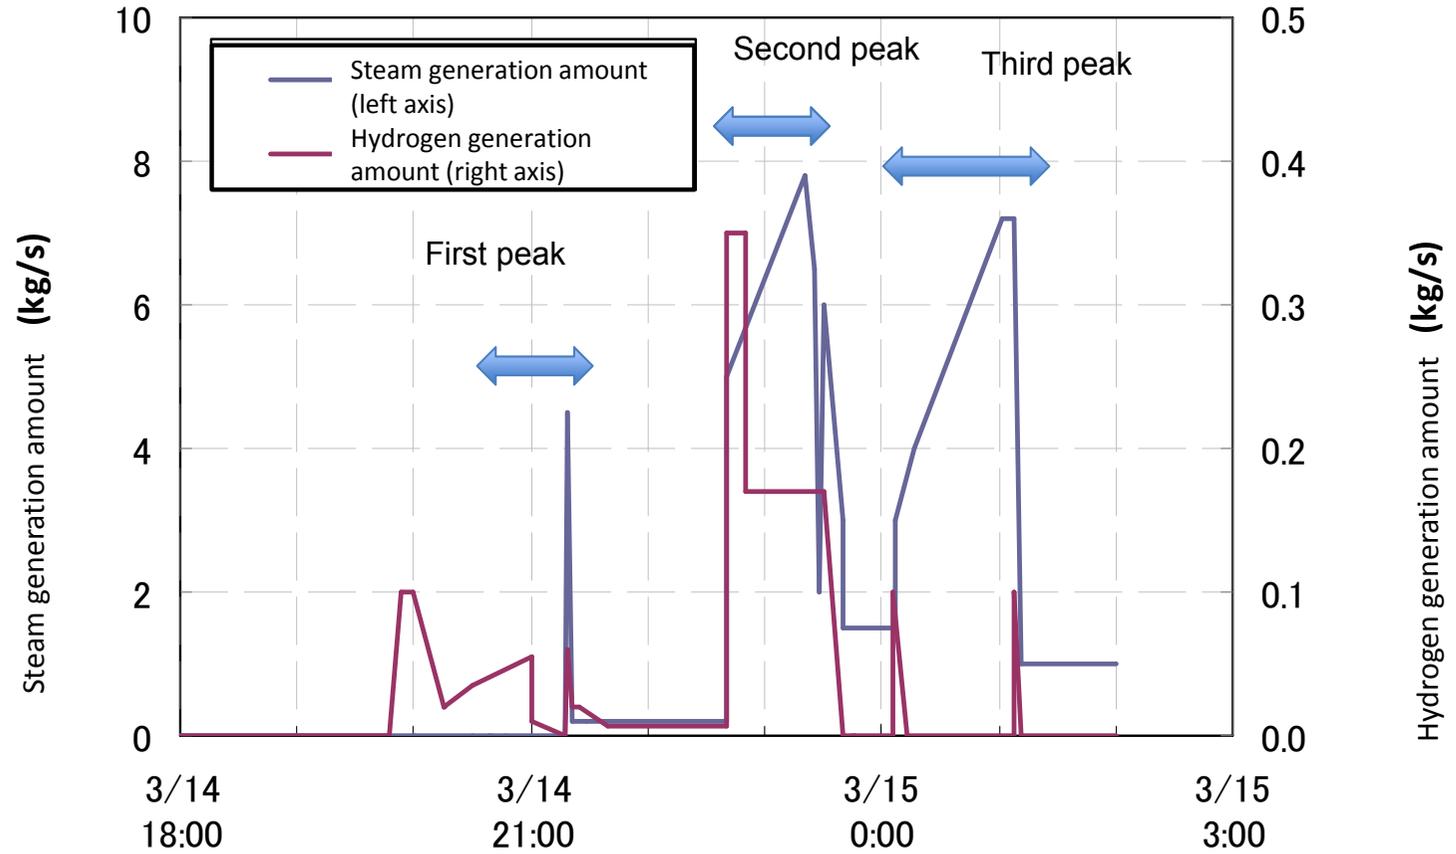
- The calculated result indicates that almost all of zirconium in the reactor reacted until the second peak.
- **Estimated that most of fuel melted during the second peak** from the relationship between hydrogen generation and energy generation due to water-zirconium reaction.

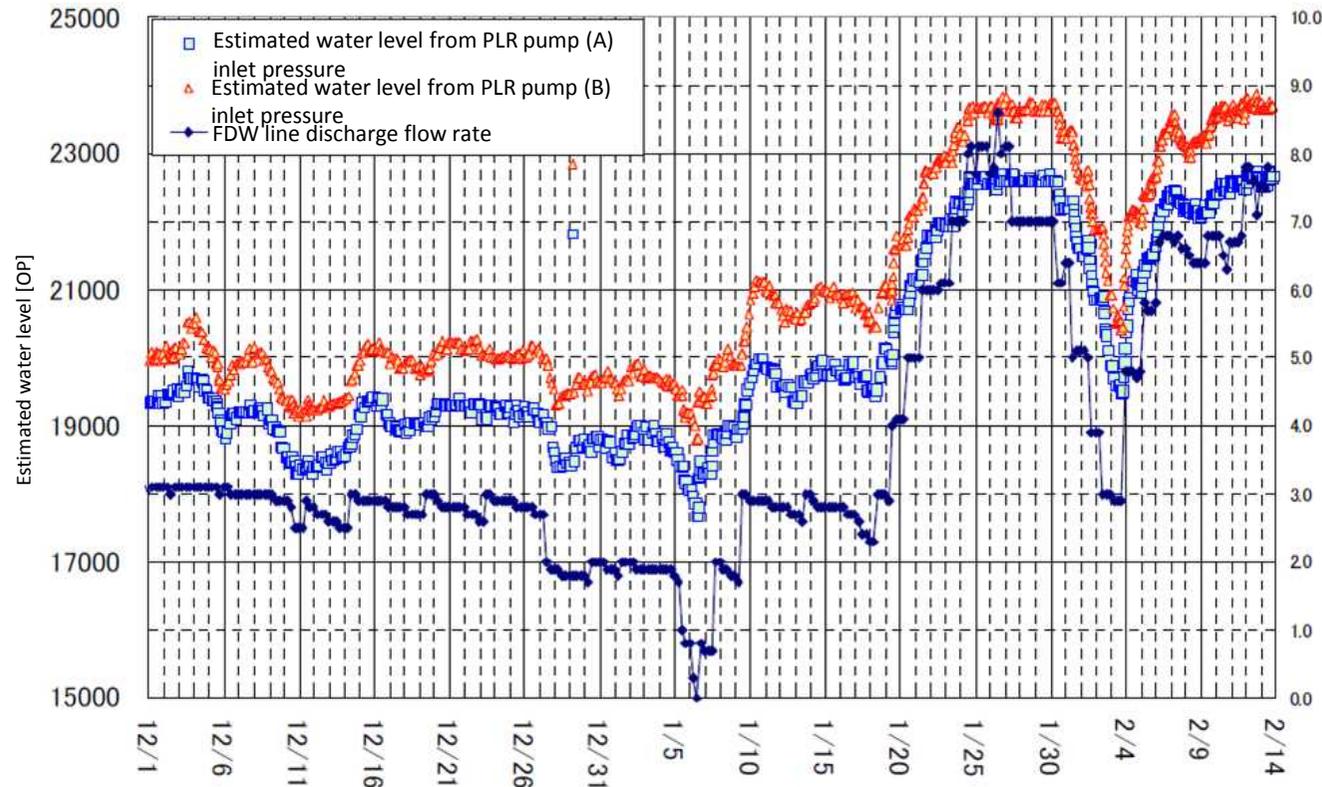
Figure Relationship between Water Injection Volume from FDW System and Water Level in Annulus (December 2011 to February 2012)

As the water injection rate increases, the water level in annulus rises.

- Possibility of water level formed outside the shroud with damage on shroud to small extent
- Because the total water injection rate is increasing, the water level in the reactor pressure vessel can be rising even though the shroud is damaged

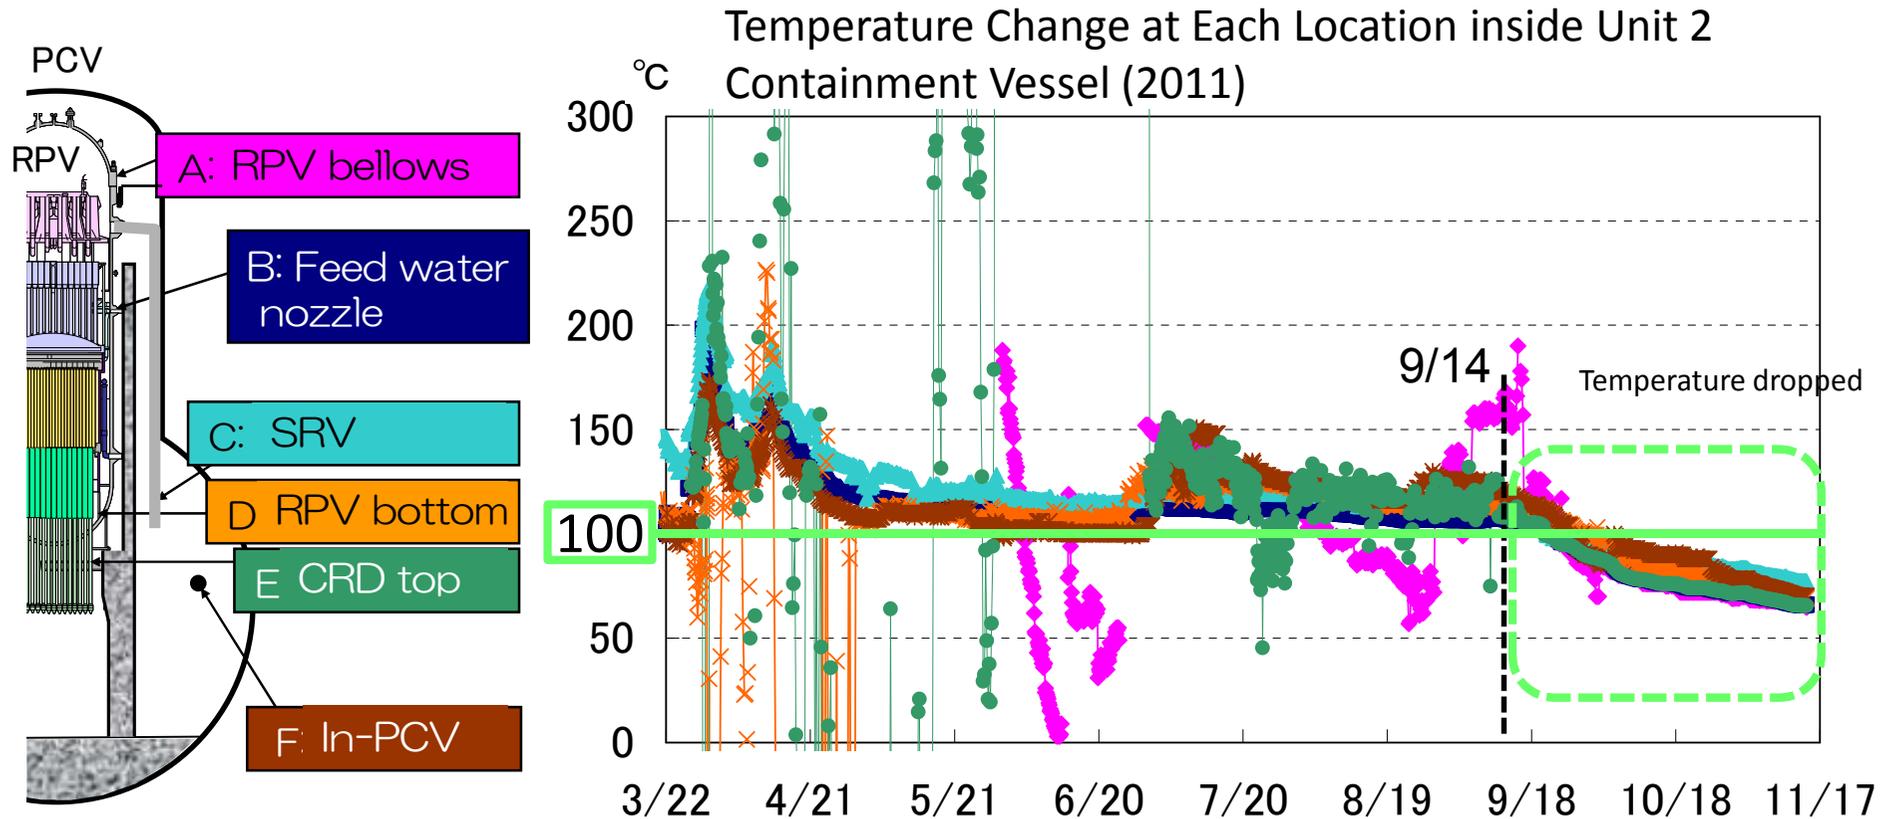
Along with water injection from CS system started on September 14, 2011, the temperatures of A to F decreased similarly

The heat source is considered to be located in the area that is cooled by water injection from CS system. This also supports that the shroud has only a minor damage.

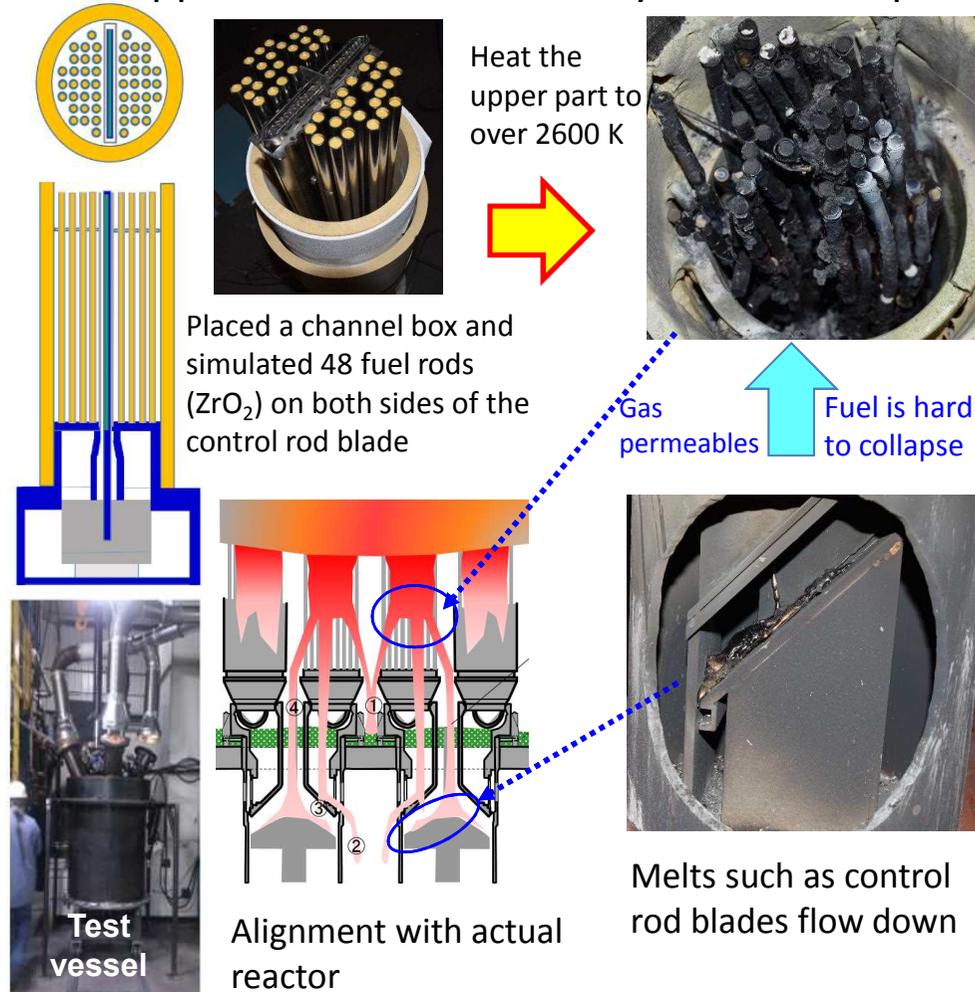
- The test result was, partly affected by radiation, that the fuel rods maintained their shape to a certain degree after heating.
- On the outer periphery of core where radiation in the shroud direction is large and the fuel temperature rise is not so high, pellets or the like could possibly remain.

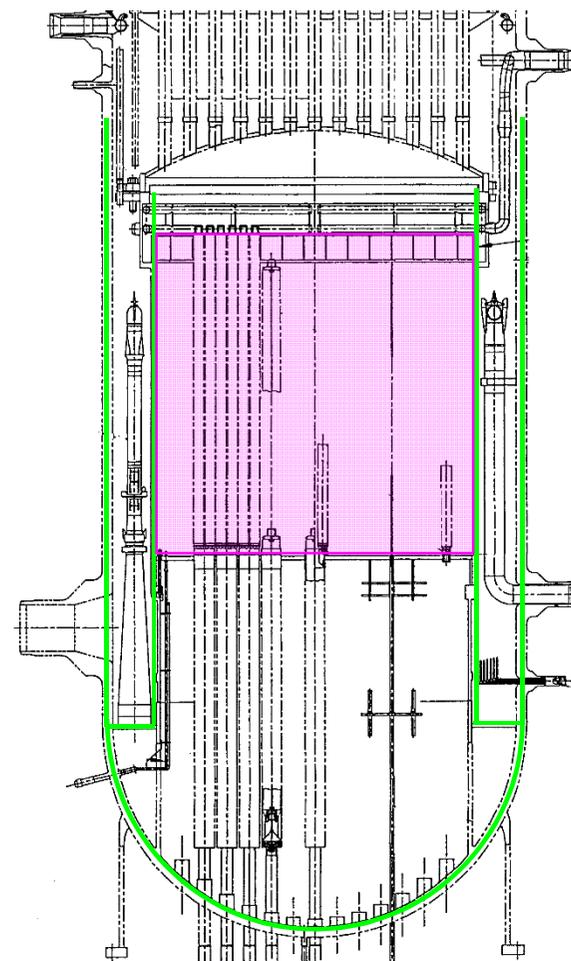
Structure of pressure vessel Lower Part

Considered that fuel fallen in the lower plenum remains at the bottom of RPV.

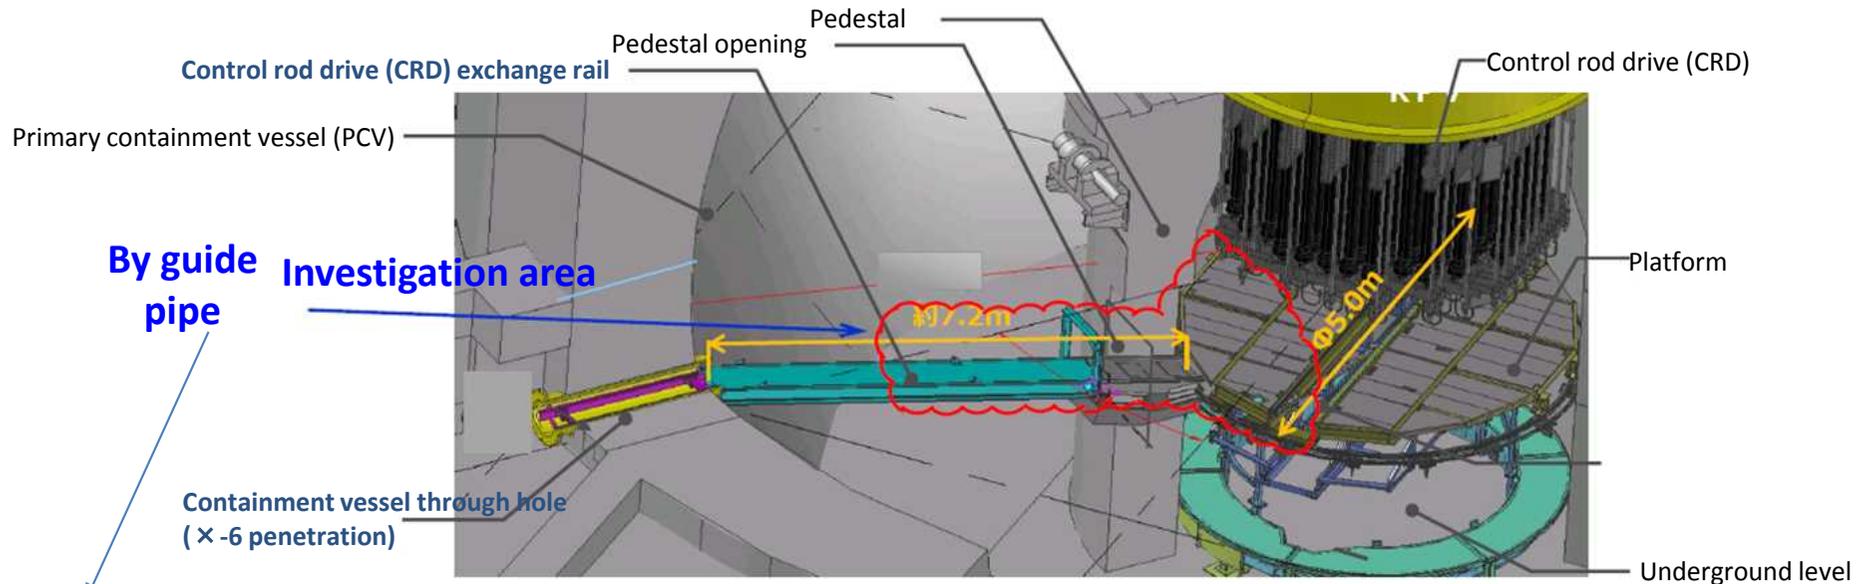
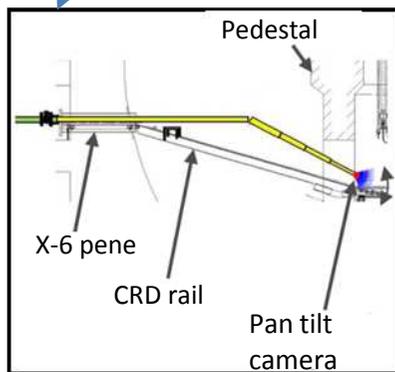
Investigation area inside the pedestal

Collected much information on the situation in pedestal from the results of processing images taken during the investigation with the guide pipe as shown on the left.

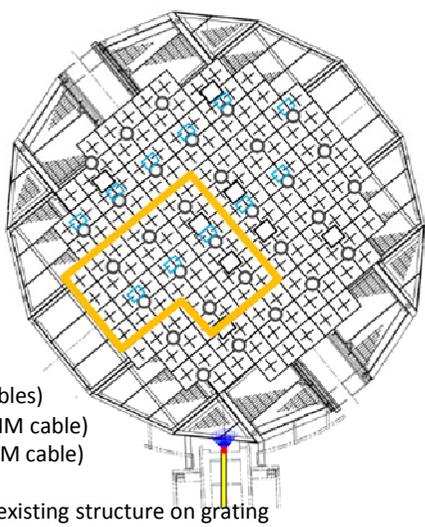
Area where PIP and LPRM cables is not locatable

• PIP or LPRM cables are observed on the far side of the area where PIP or LPRM cables are not locatable

- The area where grating dropped and the area where cables under the pressure vessel are damaged generally match.
- Deformed grating could possibly be associated with fuel debris fallen and damaged points other than those in the center of pressure vessel.

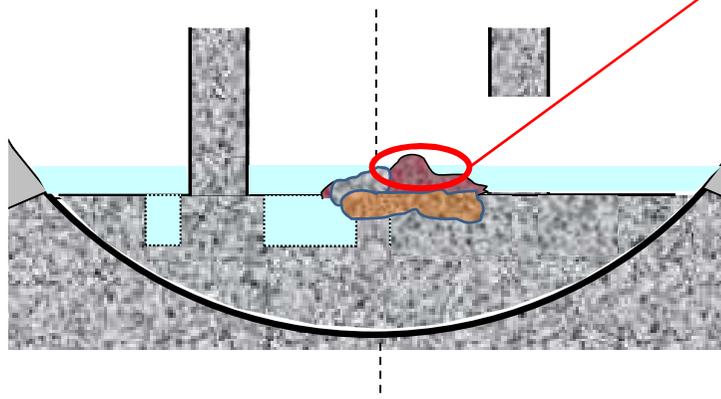
2-18 Estimation of Pedestal Part

- Observed steam rising during the PCV internal investigation.

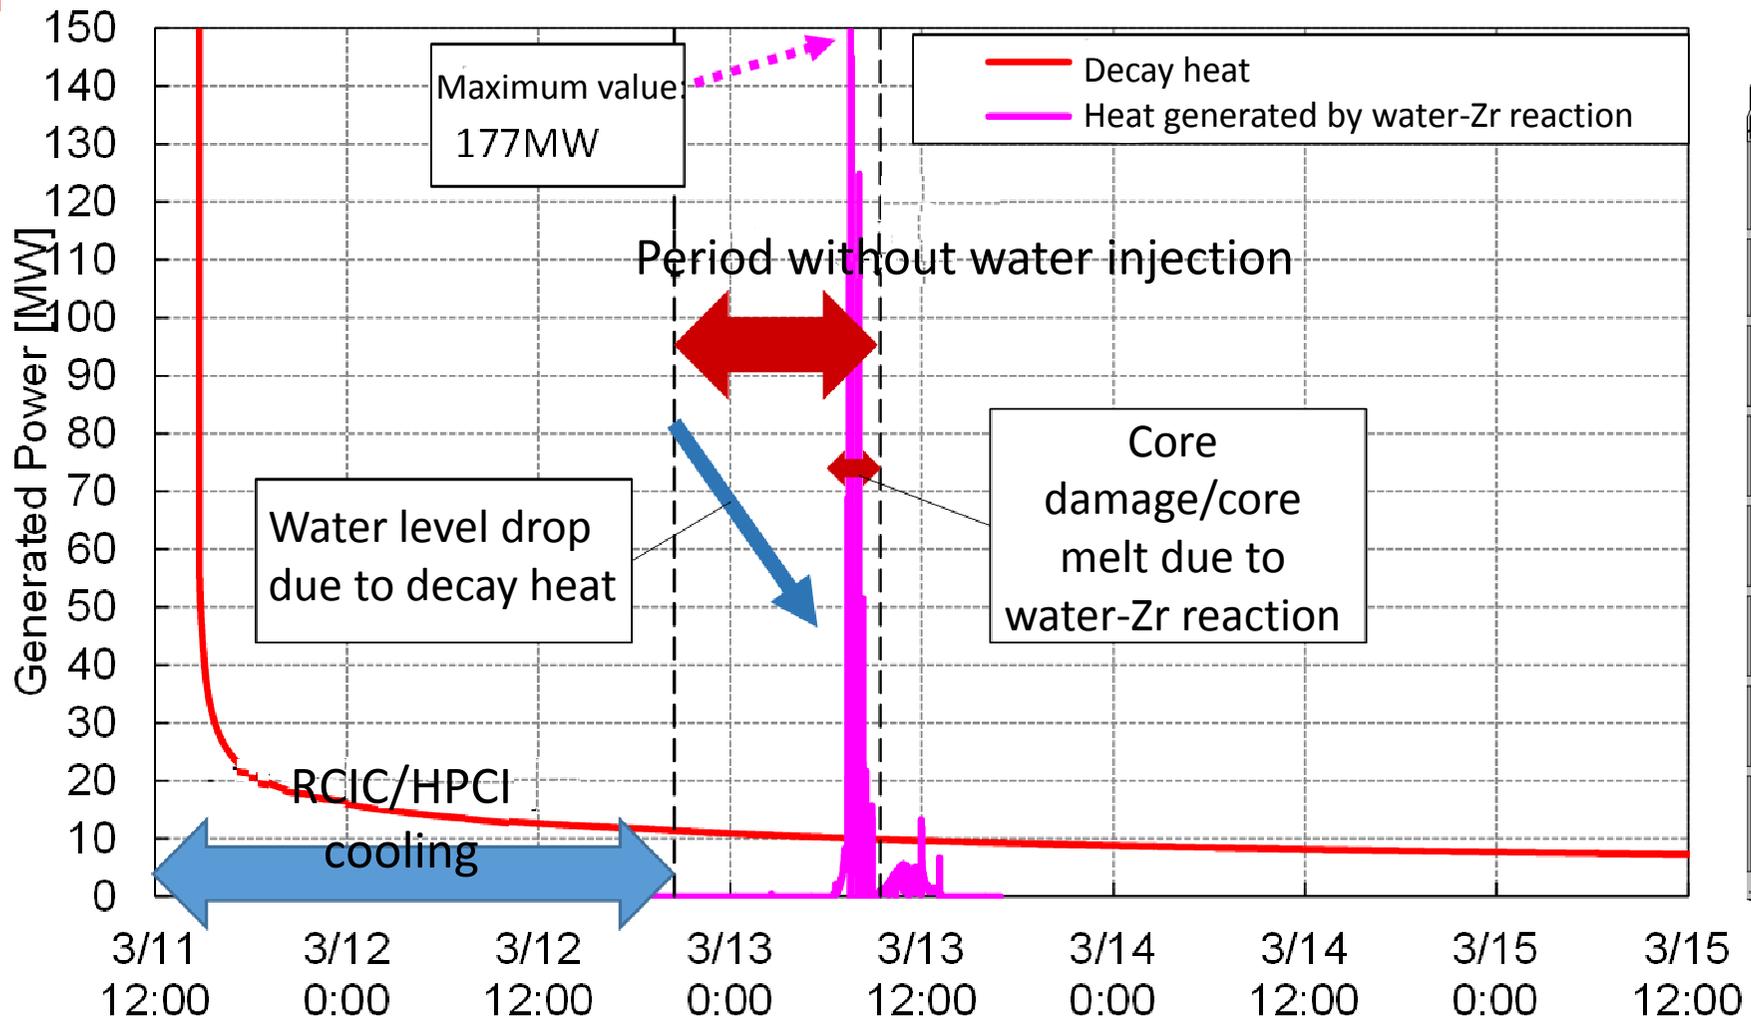
3-1 Decay Heat of Unit 3 and Heat Generated by Water-Zr Reaction

Unit 3 became uncoolable because its HPCI stopped, which resulted in core damage/meltdown during a no-injection period. Fire engine water injection made no contribution to water-Zr reactions

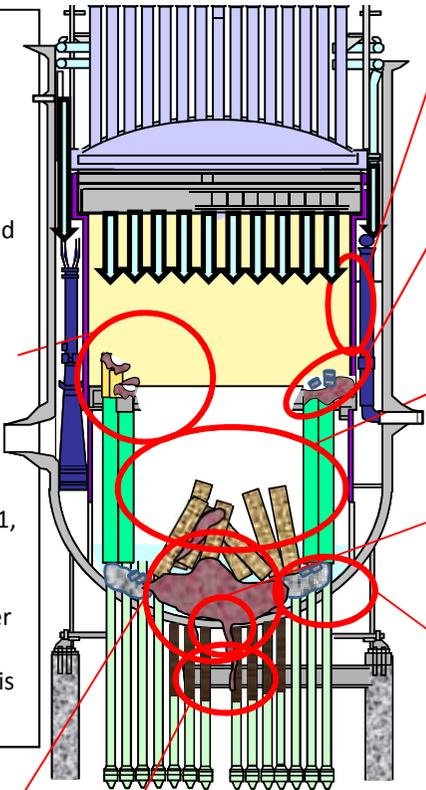
3-2 Unit 3 Estimation Diagram

- Assuming the energy amount from PCV pressure increased due to hydrogen generation, most of fuels are estimated to have melted
- Since no temperature increase was observed in each part of RPV when injection from CS system was stopped from 9 to 24 in December 2013 (keeping constant total flow by increasing flow from FDW), the amount of fuel debris in core is estimated to be small (smaller than that in Unit 2)
- Because temperature at RPV lower head dropped when water injection from CS system started (September 1, 2011), fuel debris is estimated to in lower plenum
- Fuel rods can exist only on the outer periphery if any
- Estimated to be general oxide debris solidified with molten fuel

- Currently, the shroud has two possibilities: sound or damaged.

- Possibility of pellets remaining on the outer periphery because the fuel temperature rise on the outer peripheral may not be so high

- Lower part of pressure vessel can be damaged because MCCI is considered to occur

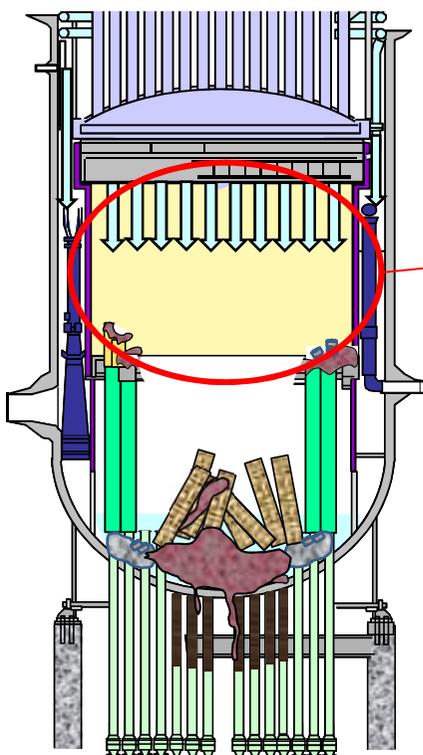
3-3 Estimated State of Core

• Assuming the energy amount from the increased PCV pressure by hydrogen generation, it is estimated that most of fuels have melted

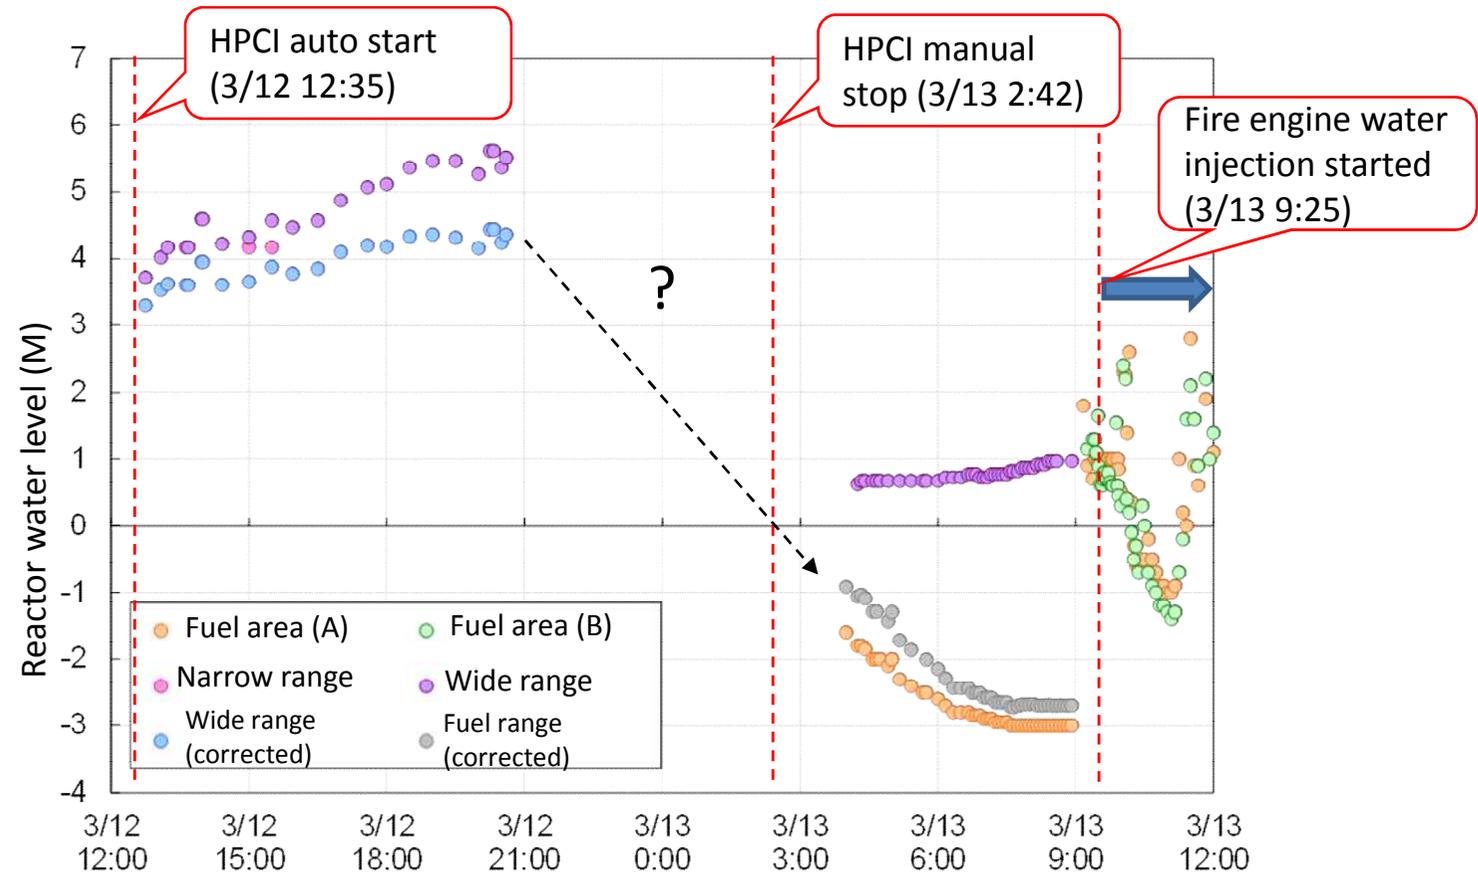
3-4 Change in Reactor Water Level

- Before HPCI was manually stopped, the reactor pressure was lower than the HPCI operable range and the HPCI discharge pressure was also low, which suggests a possibility that water injection into the nuclear reactor could be insufficient before stopping HPCI
- Fire engine water injection started at 9:25 on March 13, damage to fuel is considered to have progressed during the period when injection was not allowed.

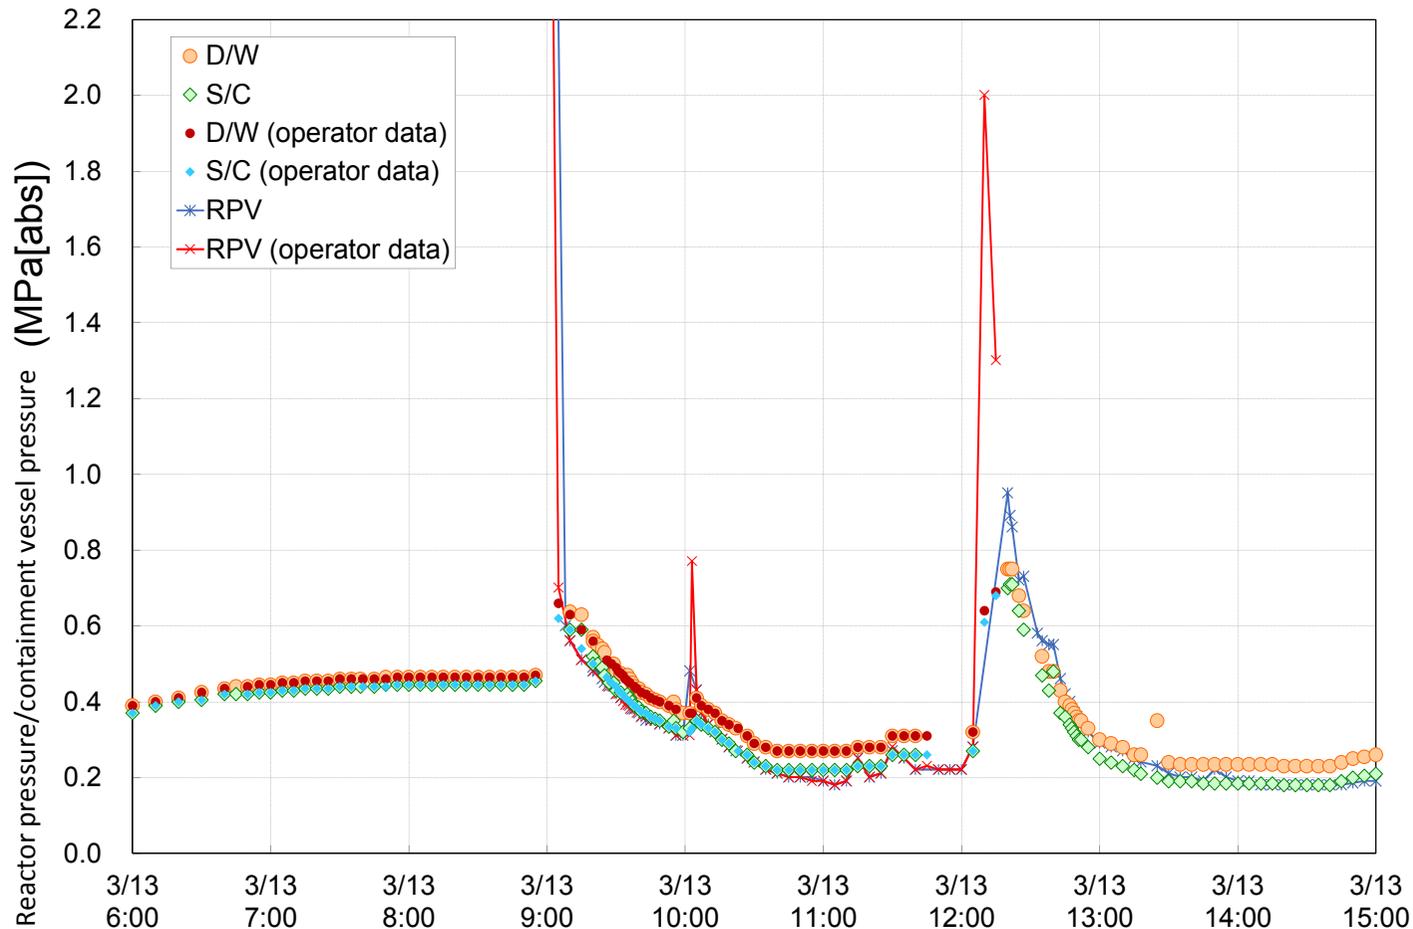
3-5 Behavior of Reactor Pressure/Containment Vessel Pressure

At around 9 o'clock and past 12 o'clock on March 13, 2011, the containment pressure has increased significantly.

Like Unit 2, this could be caused by a large amount of hydrogen generated there and most of the fuel could have melted.

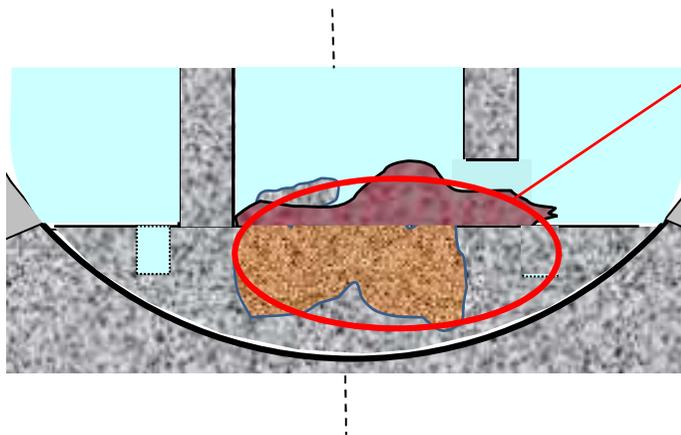
3-6 Estimation of Pedestal Part

- In addition to Unit 4, Unit 3 also experienced an explosion to which hydrogen generated by MCCI could possibly have contributed.
- Meanwhile, DW spraying was performed for more than 1 h from 7:39 on March 13 in response to the accident. Diffusion of fuel debris could have been suppressed considering a water level on DW floor during pressure vessel breakage.
- Estimated that fuel debris diffuses outside the pedestal through the pedestal opening but has not reached shell attack.

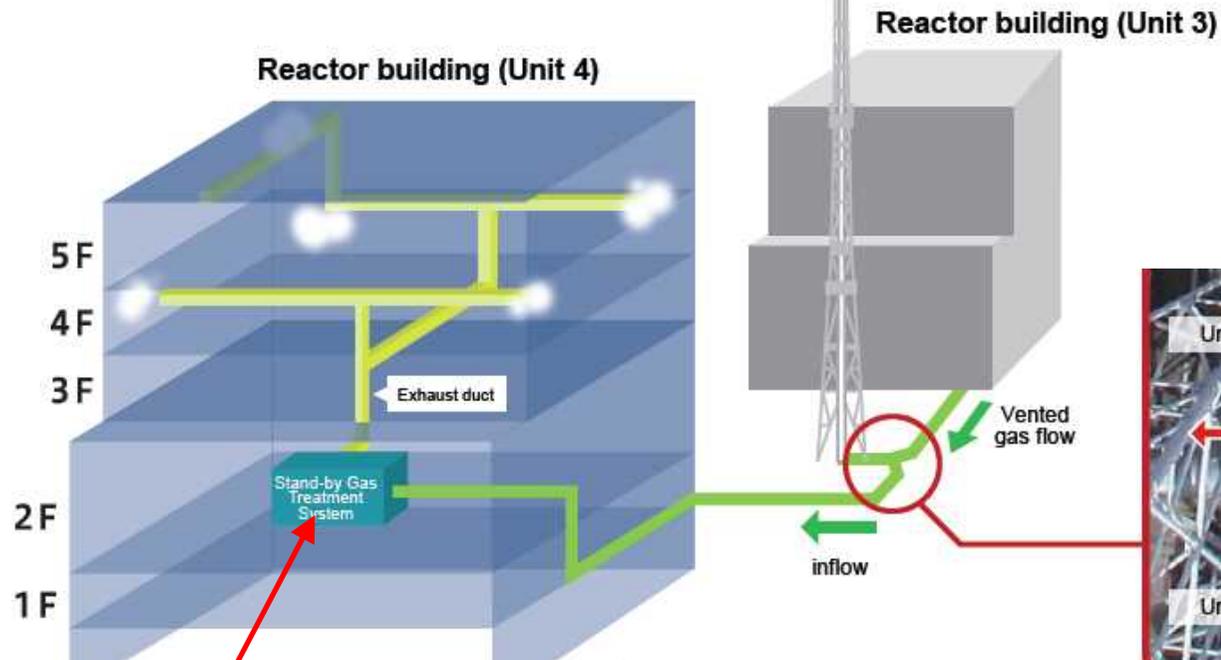
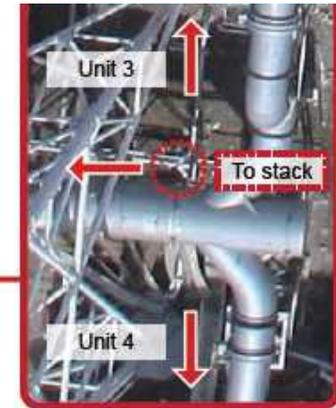
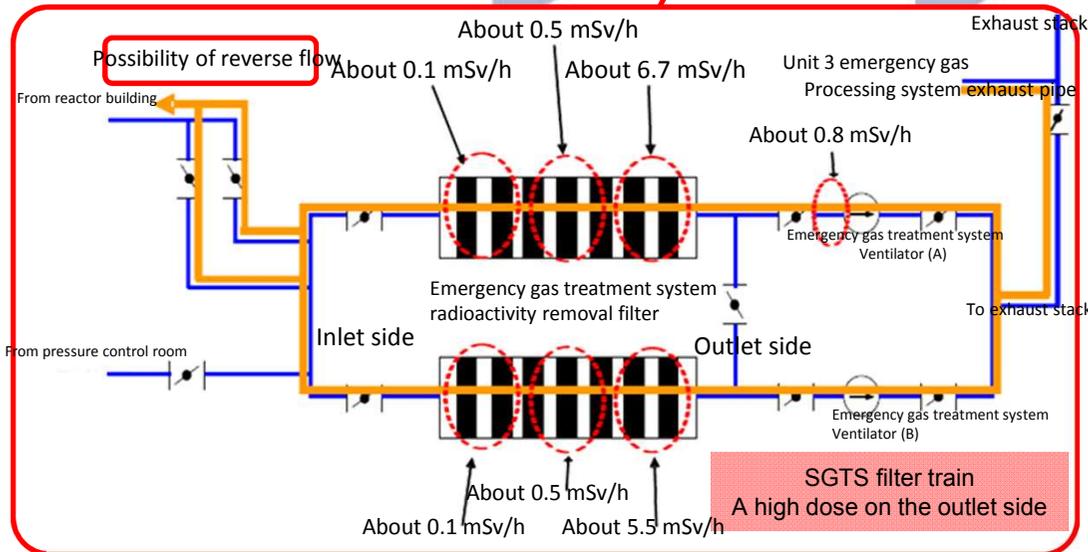
3-7 Flow into Unit 4 from Unit 3

In Unit 4, hydrogen explosion occurred in the reactor building around 6:14 on March 15. The vent gas of Unit 3 is considered to be getting into the Unit 4 reactor building.

Units 3 and 4 exploded due to hydrogen generated in Unit 3. In addition to the hydrogen generated by water-Zr reaction, the hydrogen generated by MCCI could possibly have contributed to explosion.
