The 8<sup>th</sup> International Forum on the Decommissioning of  
the Fukushima Daiichi Nuclear Power Station

# Initiatives for Fuel Debris Retrieval at Fukushima Daiichi Nuclear Power Station

August 26, 2024

Fukushima Daiichi Decontamination and Decommissioning Engineering Company,  
Tokyo Electric Power Company Holdings, Inc.

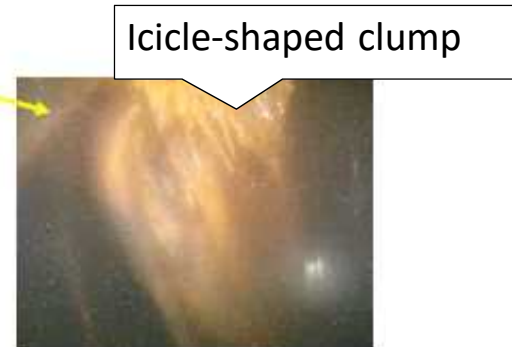
Icicle-shaped clump

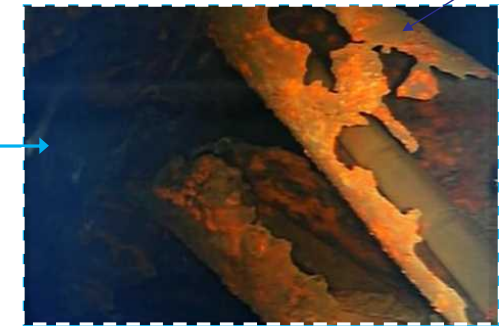
**Flange of CRD housing**
